AUTOMOTIVE CONSULTING ENGINEERS LTD

CONFIDENTIAL TECHNICAL REPORT

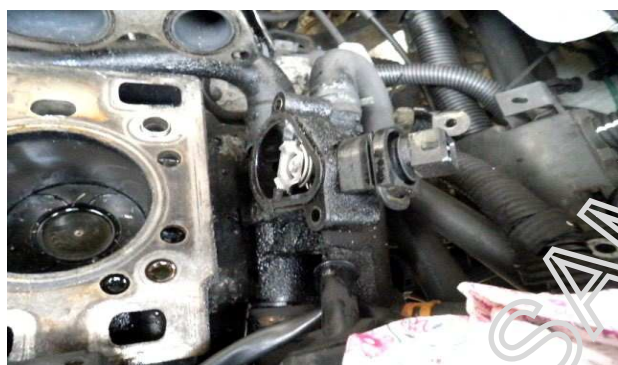
R22	A longstanding oil leak however, was noted at the rear of the engine, which was contaminated with dirt / road traffic film. The repairers indicated that 2 litres of engine oil had to be added to the engine when it originally arrived in their possession. This could not be confirmed at the time of our visit.
R23	The repairers then indicated that in their opinion, the tensioner had failed and had been retained by ***. They indicated the tensioner had over-ridden and lost tension. This could not be confirmed, as the failed components were not available for examination.
R24	Examination of the rockers revealed them all to be visibly intact and not showing signs of physical damage. However, we would recommend that the rockers be considered for replacement, as clearly shock-loading will have been transferred from the valves to the rockers in the failure.
R25	Examination of the rocker shafts also revealed them to be intact and bright but did appear to be distorted, although the contact at the repairers suggested that when fitted to the cylinder head, they would be straightened by tensioning the head, we anticipate they should not be in this condition and as such, should also be considered for replacement.

R26	The dirt contamination at the rear of the engine would suggest an oil leak had either developed from the cam cover or head gasket.

Evidence of oil leak

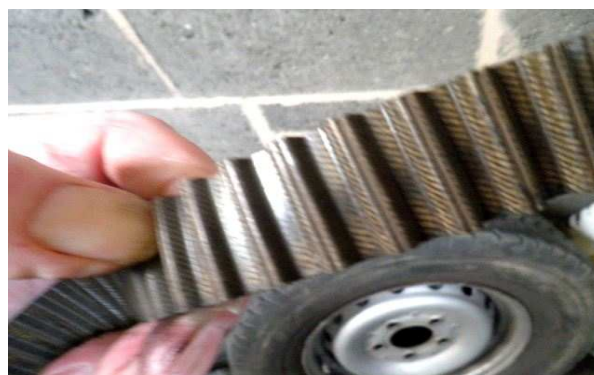
Original timing belt

R13	It is common practice during the timing belt replacement to replace both components as a matched pair.
R14	The replacement-timing belt that had been fitted and tensioner were not available for examination and had reportedly been sent to ****for examination. Although apparently *** have / are supplying new replacement parts as a good will gesture, it appears that they have not accepted liability.
R15	Examination of the pistons, which were still insitu, revealed evidence of valve to piston crown impact. The impact appeared nominal and did not show signs of any significant damage.
R16	We would recommend however, that the piston crowns are cleaned and checked for any minute fractures or cracks.
R17	We would conclude at this stage however, we do not consider this will have developed and the pistons still appeared visually serviceable.
R18	Examination of the cylinder bores revealed them to be polished and glazed with a normal carbon wear ridge to the bore tops. The bores showed no evidence of any significant damage, although the number 1 had a slight polish mark but this did not appear to be related to the failure, which had developed.

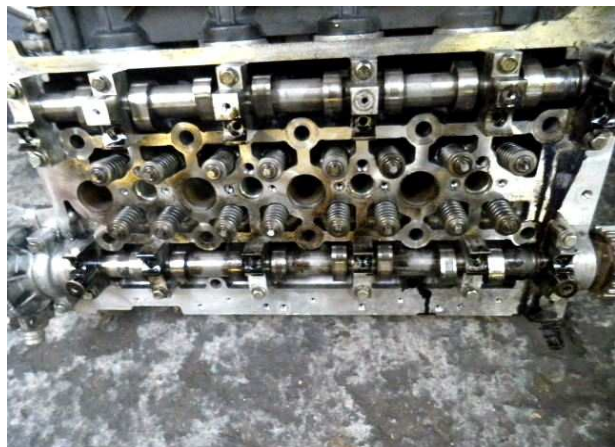
Cylinder head cam side

REPORT CONTINUED:	
R7	The head face however, had not been skimmed and we would recommend, as good engineering practice, that the head face be skimmed and a pressure test be completed to the cylinder head.
R8	We also noted that the cams appeared serviceable with no signs of any excessive wear or damage to the cam lobes. The cam lobes were bright and did not show signs of lack of lubrication.
R9	The camshafts at the time of the inspection were situated in the cylinder head.
R10	The head gasket is of a shim type and showed no positive signs of breach, blow or splitting and appeared to have been serviceable prior to removal.
R11	The original timing belt from the vehicle was presented for inspection. The belt was intact and in good condition and showed no evidence of any root cracking. The belt however, was due for replacement.
R12	The tensioner for this belt was also presented and again appeared to be in a serviceable state, with no evidence of any excessive wear or damage.

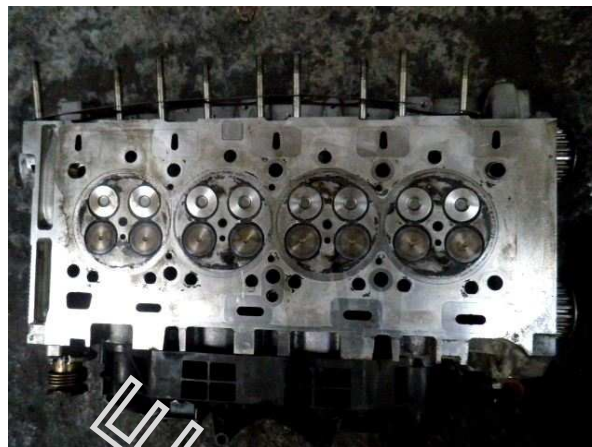
Cylinder head valve side

R3	We carried out an inspection to the engine in its partly dismantled state, the engine being of a 16-valve, 4-cylinder diesel type.		
R4	The cylinder head had been returned from the specialist and had been subject to repair work.		
R5	All 16 valves had been replaced prior to our inspection.		
R6	Careful examination of the cylinder head revealed it to be visually serviceable with no signs of any burning, cracking or erosion to the combustion faces and the valves did appear to be seated correctly at the time of the inspection, being of a replacement type.

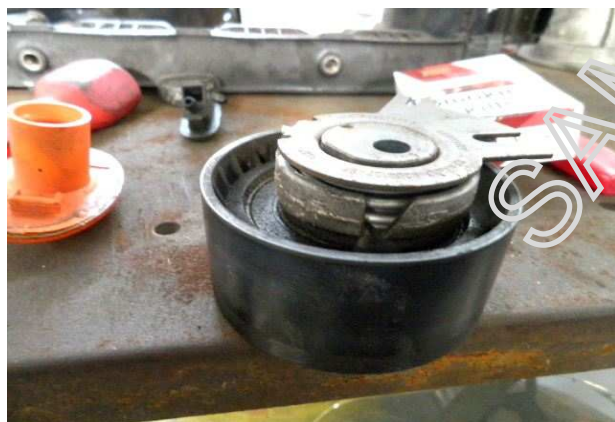
Original timing belt tensioner

R19	The repairers suggested that the engine might have suffered a fluid lock causing the condition identified. We rotated the engine and confirmed that the piston heights were all even. There was no evidence of fluid lock as was being suggested.
R20	Examination of the turbo charger, which was still insitu, revealed it to be intact. There was no evidence of any excessive play to the turbo charger impeller.
R21	There were no signs of any excessive oil contamination to the induction system. As such, the theory that the engine had suffered a fluid lock appeared flawed and in our opinion, would not account for the valve to piston crown contact in any case.
