AUTOMOTIVE CONSULTING ENGINEERS LTD

CONFIDENTIAL TECHNICAL REPORT

Report No	392688	Vehicle	Skoda Fabia SE 12V
Your Ref	900000315254	Reg No	FY60VSL

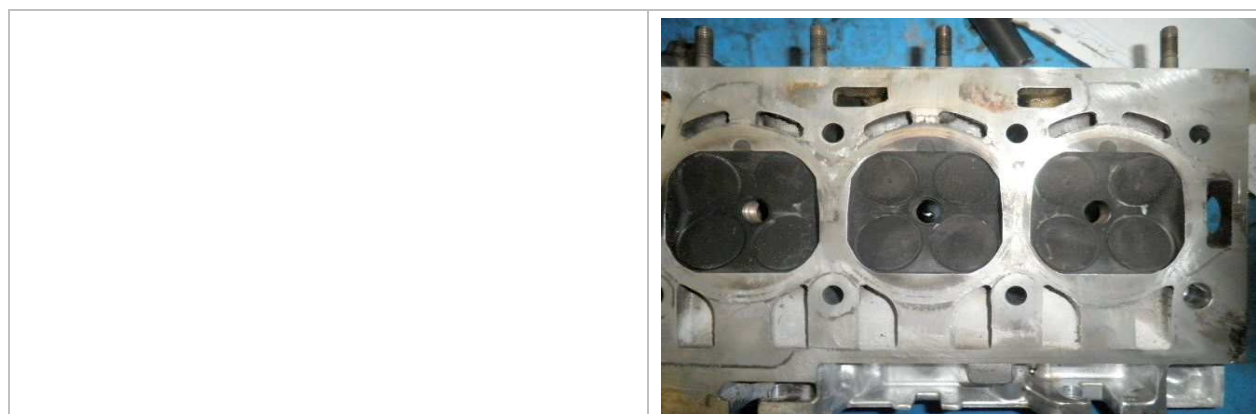
Cylinder head

O1	In our opinion based on the visible evidence we would conclude that the engine was showing signs of extensive overheating damage.
O2	The cylinder head has been tested and is distorted beyond the manufacturers tolerance and is in need of replacement.
O3	We can also confirm that the cylinder bores were showing signs of overheating discolouration patches and the early stages of piston ring partial seizure as such we would conclude that the engine was uneconomical to repair.
O4	The engine had suffered very high internal core temperatures and cylinder head lift leading to the consequential damage apparent.

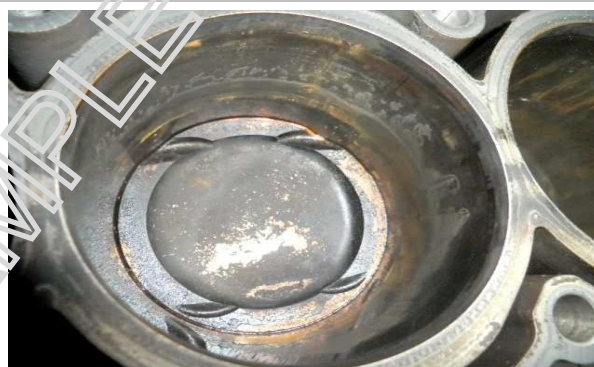
Cylinder bore

R5	The cylinder bores showed signs of water staining and discolouration patches and also surface corrosion which had developed as a result of the engine standing with coolant present within the cylinder bores, this had not had a detrimental affect as the engine was showing signs of severe internal engine high core temperatures, dark areas were also apparent around each combustion sealing ring area consistent with the gasket breaching allowing combustion gas to leak out.
R6	The head gasket was intact and due to its construction showed no positive evidence of failure in any specific area although the head gasket showed signs of cylinder head lift on all cylinders.
R7	The thermostat housing was found to have melted consistent with very high internal core temperatures.
R8	The water pump appeared to be intact and serviceable as did the water pumps plastic impellor.
R9	The head had been sent for specialist testing and this had revealed 0.15mm of distortion which is outside the manufactures tolerance apart from this the head did not show signs of burning, cracking or erosion.

R10	The valves appeared to be seating correctly within the head and showed no evidence of any burning or damage.
R11	The cylinder bore surfaces showed signs of marking which may indicate the early stages of piston ring seizure.
R12	The auxiliary belt tensioner had collapsed and the repairers indicated the auxiliary belt was missing prior to dismantling and was most likely lost at the scene of the incident.
R13	Examination of an idler wheel which forms part of the tensioner assembly, revealed it had collapsed and disintegrated, closer examination of the tensioner revealed that the back showed signs of chatter marks and wear had also developed to the support boss which would result in excessive movement within the tensioner assembly and would either suggest insecurity in the assemble or wear and deterioration had been the initiating cause of the failure of the tensioner assembly.

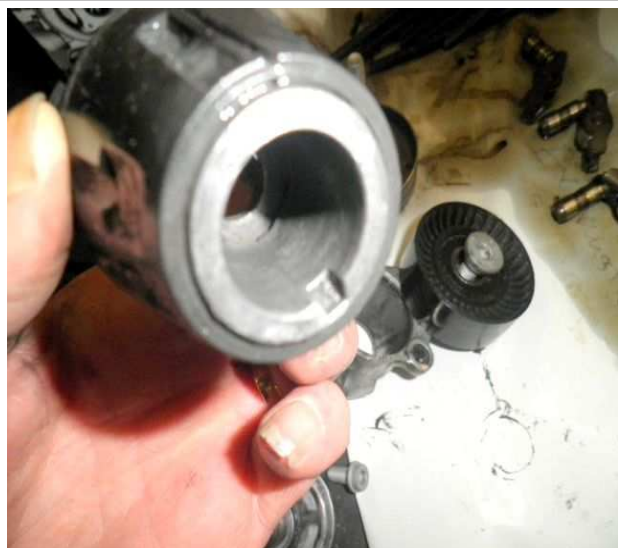
Aux belt tensioner outer housing

O5	We would consider based on the condition of the components that the initiating cause of the fault was that the auxiliary belt tensioner had collapsed in service due to wear and deterioration, clearly this condition will need to be referred to the manufacturer for consideration, this has resulted in displacement of the auxiliary drive belt which drives the alternator, water pump and air conditioning following displacement of the belt, clearly these components would be inoperative and the alternator warning light would illuminate, the air conditioning system would be inoperative and the water pump would not be driven, this would prevent coolant circulation within the engine leading to very high engine core temperatures which should have been apparent on the manufacturers warning device, we would therefore conclude that the initiating cause would be unavoidable from the operators perspective but the extent of the consequential damage would clearly indicate the vehicle had remained in service whilst a defect of a catastrophic type had developed and leading to consequential damage which could have been avoided by a more prompt response, with the illumination of the alternator warning light, failure of the air conditioning system to be operative and in the form of very high operating temperatures and on the manufacturers warning device the vehicle should have been taken out of service which would have prevented the now apparent consequential damage to the engine necessitating in its replacement.
