Universal

TECHNICAL BULLETIN 005

Problem units and unit identification

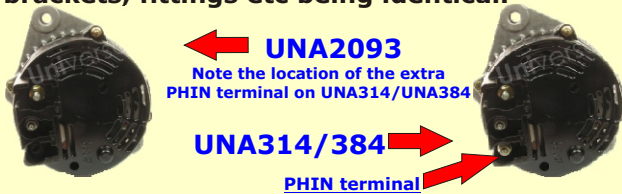
This is one of those units that must be applied with O.E. numbers, especially as the alternator options look almost identical apart from an extra terminal, the PHIN terminal (Phase input/internal) located on the back of the UNA314/UNA384 unit.

As the task of changing the alternator is reported to take upwards of three hours, it is vital to get the correct unit as they will both fit onto the car, the brackets, fittings etc being identical.
