Scope of Works

This Asbestos Management Survey of *Property Address* was commissioned on *insert date*. The purpose of the survey was to provide the client with sufficient information to enable them to comply with their duties under Regulation 4 of the Control of Asbestos Regulations 2012.

Survey ref: DJ150414A
Sample no: 01
Item: ceiling panels
Location: CP level filing area
Room no: -1/55

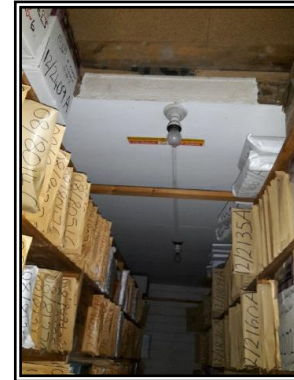
Lab Result: amosite & chrysotile

Material Risk Assessment		
Product type	<i>insulation board</i>	2
Damage	<i>none</i>	0
Surface treatment	<i>sealed</i>	1
Asbestos type	<i>amosite</i>	2
Material Risk Score		5
Priority Assessment		
Normal occupant activity	<i>low risk</i>	1
Likelihood of disturbance	<i>low</i>	1
Human exposure potential	<i>moderate</i>	2
Maintenance activity	<i>low</i>	1
Priority Score		5
Total Risk Score		10

Comments: Asbestos material. The ceiling panels shown are asbestos insulation board (AIB) and are a high risk material if disturbed. At the time of surveying the panels were paint sealed, in good condition and may continue to be managed in-situ. Minor repairs and painting may be carried out by a suitably trained general contractor wearing appropriate RPE/PPE and following HSE guidance work methods. If removing, this material may only be removed by a HSE-licensed contractor and disposed as hazardous waste.

Recommended action: **C**
Manage in-situ

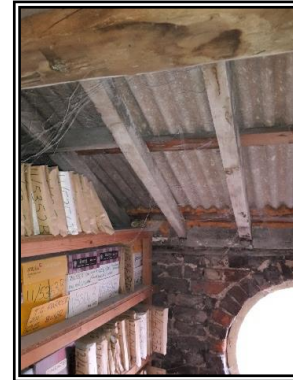
Survey ref: DJ150414A
Sample no: 02
Item: cement roof sheets
Location: GF file storage area
Room no: 0/46 & 0/47

Lab Result: chrysotile asbestos

Material Risk Assessment		
Product type	<i>cement</i>	1
Damage	<i>minor</i>	1
Surface treatment	<i>cement</i>	1
Asbestos type	<i>chrysotile</i>	1
Material Risk Score		4
Priority Assessment		
Normal occupant activity	<i>low risk</i>	1
Likelihood of disturbance	<i>low</i>	1
Human exposure potential	<i>moderate</i>	2
Maintenance activity	<i>low</i>	1
Priority Score		5
Total Risk Score		9

Comments: Asbestos material. The roof sheets and associated verge and ridge pieces are asbestos cement. Asbestos cement is a non-licensed low risk material. Repair and removal work may be carried out by a suitably trained general contractor wearing appropriate RPE/PPE and following HSE guidance work methods. At the time of surveying, the roof sheets appeared in reasonable condition and may continue to be managed in-situ.

Recommended action: **D**
Manage in-situ

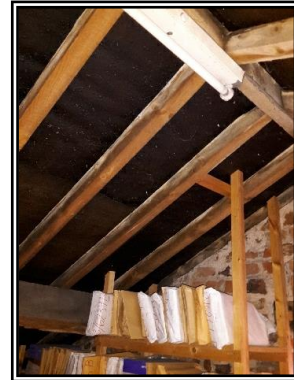
Survey ref: DJ150415A
Sample no: 03
Item: roofing felt
Location: GF file storage area
Room no: 0/46

Lab Result: N.A.D.I.S.

Comments: Non-asbestos material.

Recommended action: **E**
No action required.

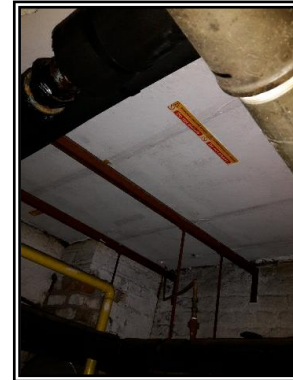
Lab Result: amosite & chrysotile

Material Risk Assessment		
Product type	<i>insulation board</i>	2
Damage	<i>none</i>	0
Surface treatment	<i>sealed</i>	1
Asbestos type	<i>amosite</i>	2
Material Risk Score		5
Priority Assessment		
Normal occupant activity	<i>low risk</i>	1
Likelihood of disturbance	<i>low</i>	1
Human exposure potential	<i>low</i>	1
Maintenance activity	<i>low</i>	1
Priority Score		4
Total Risk Score		9

Comments: Asbestos material. The ceiling panels shown are asbestos insulation board (AIB) and are a high risk material if disturbed. At the time of surveying the panels were paint sealed, in good condition and may continue to be managed in-situ. Minor repairs and painting may be carried out by a suitably trained general contractor wearing appropriate RPE/PPE and following HSE guidance work methods. If removing, this material may only be removed by a HSE-licensed contractor and disposed as hazardous waste.

Manage in-situ

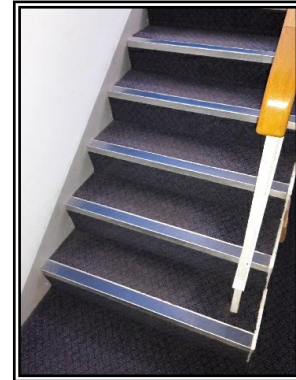
Item: blue stair nosings
Location: CP level stairwell
Room no: -1/06

Lab Result: N.A.D.I.S.

Comments: Non-asbestos material.

Recommended action: **E**
No action required.

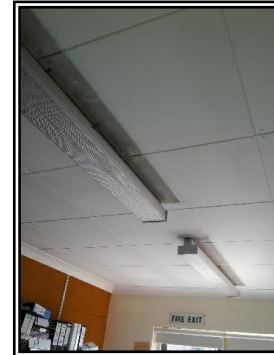
Survey ref: DJ150414A
 Sample no: 07
 Item: ceiling panels
 Location: FF office & others
 Room no: 1/37 & others (1/30-1/43)

Lab Result: amosite & chrysotile

Material Risk Assessment		
Product type	<i>insulation board</i>	2
Damage	<i>none</i>	0
Surface treatment	<i>largely sealed</i>	1
Asbestos type	<i>amosite</i>	2
Material Risk Score		5
Priority Assessment		
Normal occupant activity	<i>low risk</i>	1
Likelihood of disturbance	<i>low</i>	1
Human exposure potential	<i>high</i>	3
Maintenance activity	<i>low</i>	1
Priority Score		6
Total Risk Score		11

Comments: Asbestos material. The ceiling panels are asbestos insulation board (AIB) and are a high risk material if disturbed. At the time of surveying the panels were largely paint sealed, in good condition and may continue to be managed in-situ. Minor areas require paint sealing where light fittings have been moved. This work may be carried out by a suitably trained general contractor wearing appropriate RPE/PPE and following HSE guidance work methods. If removing, this material may only be removed by a HSE-licensed contractor and disposed as hazardous waste.

Recommended action: **C**
 Manage in-situ;
 Painting reqd in areas

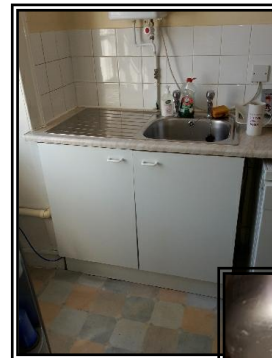
Item: sink pad
Location: 2F kitchen
Room no: 2/15

Lab Result: N.A.D.I.S.

Comments: Non-asbestos material.

Recommended action: **E**
No action required.

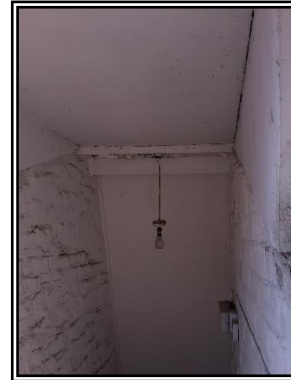
Item: ceiling panels
 Location: fire escape route
 Room no: 0/45

Lab Result: amosite & chrysotile

Material Risk Assessment		
Product type	<i>insulation board</i>	2
Damage	<i>none</i>	0
Surface treatment	<i>sealed</i>	1
Asbestos type	<i>amosite</i>	2
Material Risk Score		5
Priority Assessment		
Normal occupant activity	<i>rare activity</i>	0
Likelihood of disturbance	<i>very low</i>	0
Human exposure potential	<i>very low</i>	0
Maintenance activity	<i>low</i>	1
Priority Score		1
Total Risk Score		6

Comments: Asbestos material. The ceiling panels above the stairway of the fire escape route are asbestos insulation board (AIB) and are a high risk material if disturbed. At the time of surveying the panels were paint sealed, in good condition and may continue to be managed in-situ. Minor repairs and painting may be carried out by a suitably trained general contractor wearing appropriate RPE/PPE and following HSE guidance work methods. If removing, this material may only be removed by a HSE-licensed contractor and disposed as hazardous waste.

Recommended action: **C**
 Manage in-situ

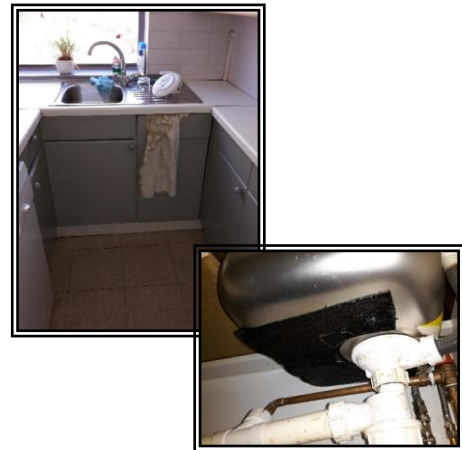
Item: sink pad
Location: GF kitchen area
Room no: 0/42

Lab Result: N.A.D.I.S.

Comments: Non-asbestos material.

Recommended action: **E**
No action required.

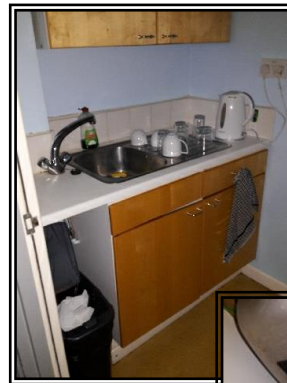
Item: sink pad
Location: GF kitchen
Room no: 0/12

Lab Result: N.A.D.I.S.

Comments: Non-asbestos material.

Recommended action: **E**
No action required.

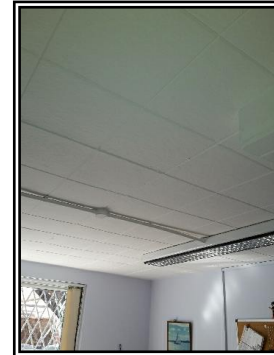
Survey ref: DJ150415A
Sample no: 12
Item: small ceiling panels
Location: CP level office & others
Room no: -1/41 & others

Lab Result: N.A.D.I.S.

Comments: Non-asbestos material. Identical non-asbestos ceiling tiles are present to rooms -1/35 to -1/41 and -1/47 to -1/53.

Recommended action: **E**
No action required.

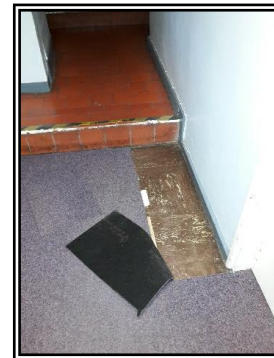
Item: flooring material
Location: CP level corridor
Room no: -1/31

Lab Result: N.A.D.I.S.

Comments: Non-asbestos material. The sampled material is present beneath the carpet tiles for the length of the corridor.

Recommended action: **E**
No action required.

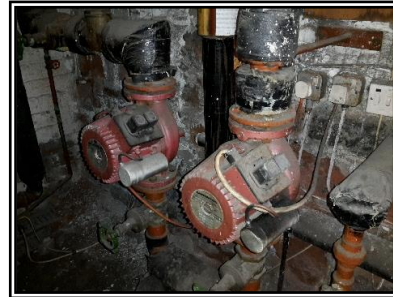
Survey ref: DJ150414A
 Sample no: 14
 Item: gasket
 Location: CP level boiler room
 Room no: -1/11

Lab Result: chrysotile asbestos

Material Risk Assessment		
Product type	<i>gasket</i>	2
Damage	<i>none</i>	0
Surface treatment	<i>largely enclosed</i>	1
Asbestos type	<i>chrysotile</i>	1
Material Risk Score		4
Priority Assessment		
Normal occupant activity	<i>rare</i>	0
Likelihood of disturbance	<i>unlikely</i>	0
Human exposure potential	<i>very low</i>	0
Maintenance activity	<i>low</i>	1
Priority Score		1
Total Risk Score		5

Comments: Asbestos material. Asbestos gaskets are a low risk material that may be managed in-situ. If necessary, removal work may be carried out by a suitably trained general contractor wearing appropriate RPE/PPE and following HSE guidance work methods. At the time of surveying, identified gaskets appeared in good condition.

Recommended action: **D**
Manage in-situ
