Barrier type: MIB 20 / 30 / 40
Controller: MLC100

Failure Corrective Action

Error message: Sensor adjustment

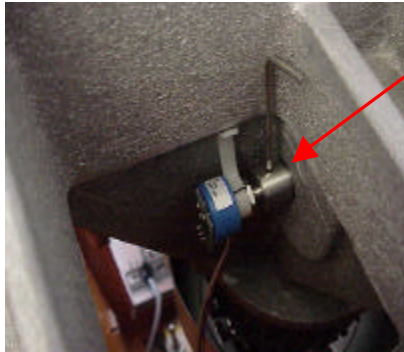
Check the actual sensor data at the open barrier as per to the operating manual annex 8.1. In case of the actual value is differing just a little from the must data the swing angle sensor can be re-adjusted (see operating manual annex 8.1)

Release the allen screw in open boom position and pull out the sensor

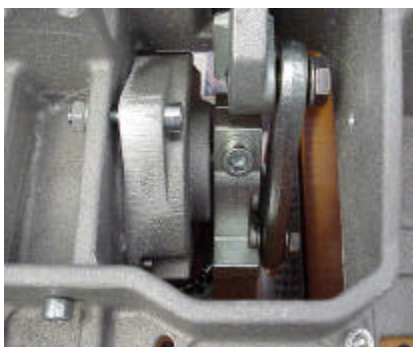
In the event of the value differs considerable from the must value or the error message shows once again "adjust sensor" after you have re-adjusted the sensor just short time ago in all probability, the error is caused by a slipping lever.

- switch off power
- open barrier
- detach barrier boom
- remove the tension springs
- put the lever in good position (as shown at the picture beside)
