CV32D Product Manual

Report No. : ES 25108

1-off Switchbox, CV3

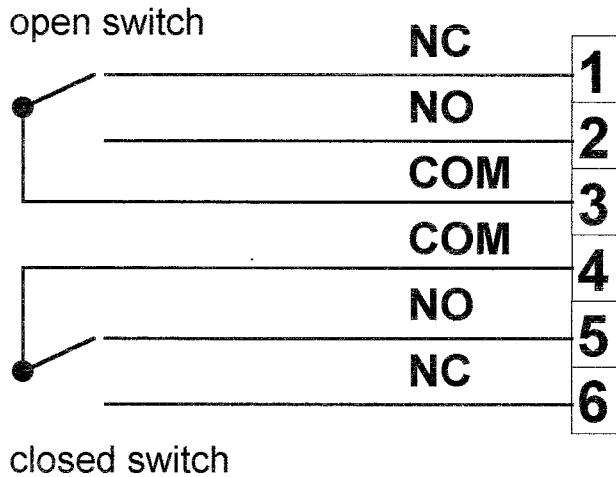
CV32 Switchbox

**Containing 2 V3 Micro-switches
(Shown in closed position)**

Wiring Diagram Ref:- WD01CV32
