## Structural Repair

We provide a wide range of repair solutions to address structural problems including cracked or compromised masonry, bowing walls, failed structural elements, partial collapses and subsidence issues. We're well versed in the repair of structural concrete and the installation of masonry reinforcement systems.

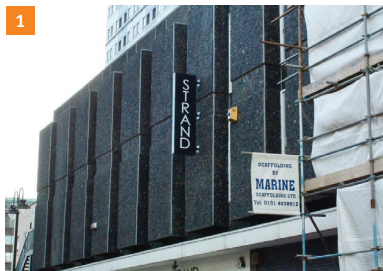
### 1 Saville Row

Works to address widespread failure of exposed aggregate pre-cast concrete panels. Steel reinforcement was fully exposed, cleaned and treated. Polymer modified mortar was made to give the desired strength characteristics and allow the 40mm whinstone aggregate to be embedded into the repair, thus replicating the original appearance.

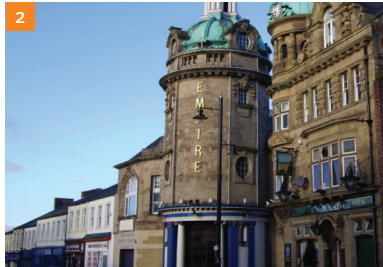
### 2 Sunderland Empire

Discreet yet major structural repairs to stabilise masonry using Helifix stainless steel reinforcement to reinstate the structural integrity. Concrete repairs were undertaken to defective lintels and heavy duty metal window bars which had contributed to cracks in the masonry were removed. The scheme also required extensive repointing.

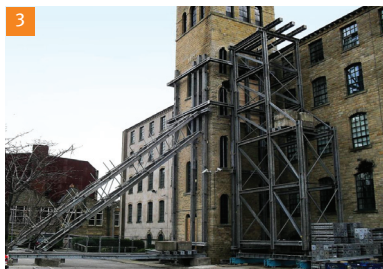
### 3 Lockbridge Mill

Non-disruptive repair scheme to restore full structural integrity to the tower of a 19th century former mill house which had experienced a partial collapse after bulging was discovered. Approx. 200m of paired helical bar was installed to tie-in and reinforce the stonework and around 700 Cemflex ties were also installed to consolidate the rubble fill walls.

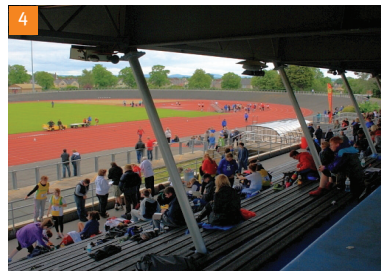
### 4 Clairville Stadium

St Astier was commissioned to carry out a structural survey of the reinforced concrete elements on the three external elevations of the stadium building. Following on from the survey, we carried out a programme of repairs to the concrete columns and ring beams of the grandstand and applied elastomeric coatings as a protective measure.

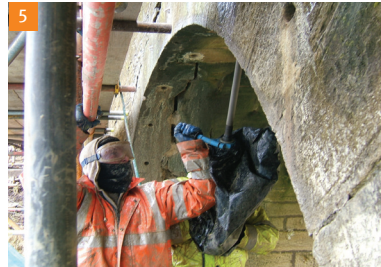
### 5 Wainford Bridge

Structural repair and stabilisation works using to the grade II listed Wainford Bridge spanning the river Till in Northumberland. A series of Cintec anchors were installed to reconnect the downstream arch of the bridge which, had over the years become detached along the top line of the voussoirs as result of surface water from the adjacent hills.

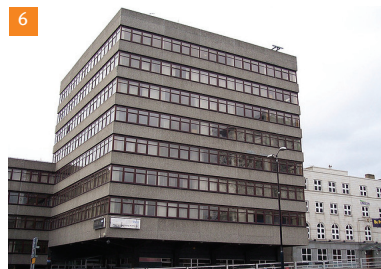
### 6 Bridge House

Concrete repairs to exposed aggregate concrete panels on a multistorey office building in the heart of Newcastle. Repairs were carried out from cradles due to the busy city centre location and access restrictions. Works centred on the removal of defective concrete, cleaning and protection of steel reinforcement and application of repair mortars.
