Tap water with extreme hardness

Ringsjön is a lake in southern Sweden from which tap water is drawn. The very hard water (dH 11) imposes severe stress on the equipment used. After 4-6 years' operation, four SWEP heat exchangers used for heating the tap water were brought to SWEP's laboratory for testing.

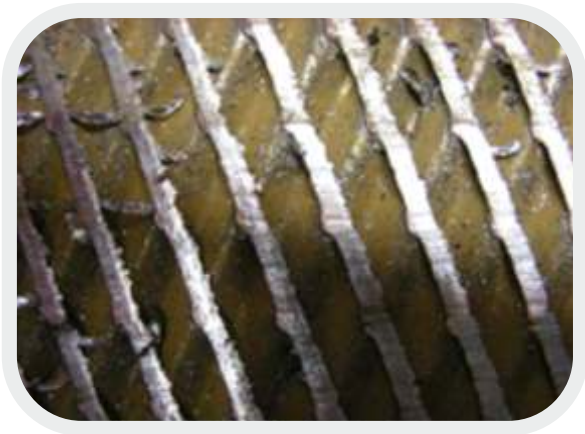
Visual reference, tap water circuit

The units showed signs of mild fouling, but were still fully functional. The purpose was to observe how the heat exchangers had been affected by the hard water, and to evaluate a biodynamic CIP fluid for removing carbonates and metal oxides without the risk of corrosion. Thermal and hydraulic performance tests were conducted before and after CIP treatment on the tap water side. The same tests were used on all four units to verify the effect.

The test results showed improvements in thermal performance by 5% and in hydraulic performance by 2%. A visual inspection of a sectioned unit confirmed that the lime scale and metal oxides were completely removed, and testing also revealed no signs of internal or external leakage.

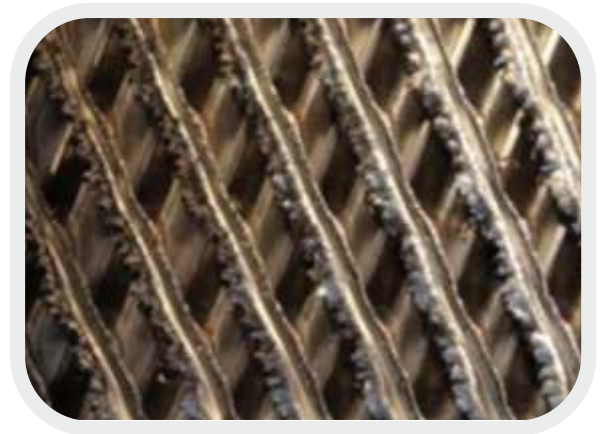
Cleaned tap water circuit

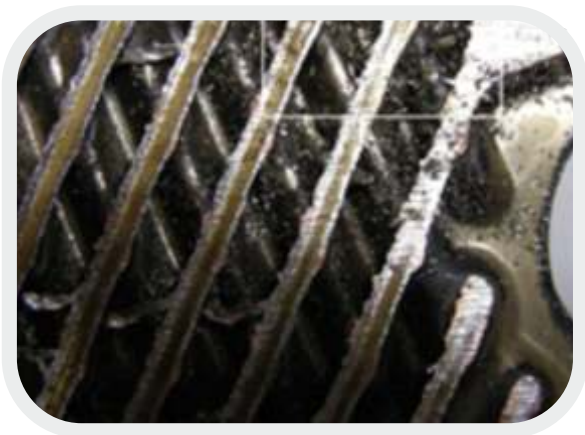
Visual reference, primary water circuit

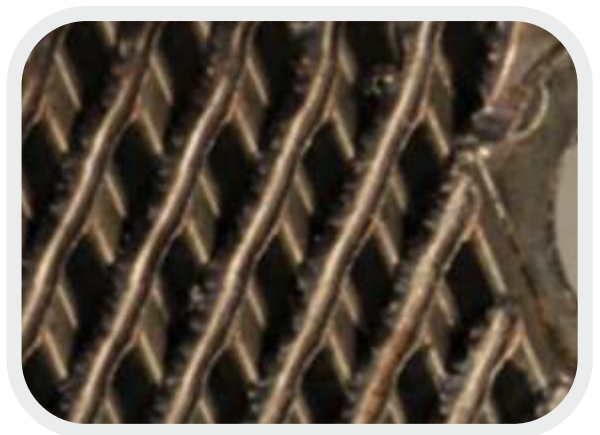
Cleaned primary water circuit
