# ScaleBuster – maintenance-free operational service for over 15 years

James Hornsby School, Basildon, Essex

To investigate the useful service life of three different sized ScaleBuster units that had been in use within the school for a period in excess of 15 years. To assess how the water treated by the use of ScaleBusters had affected the calorifiers within the system.

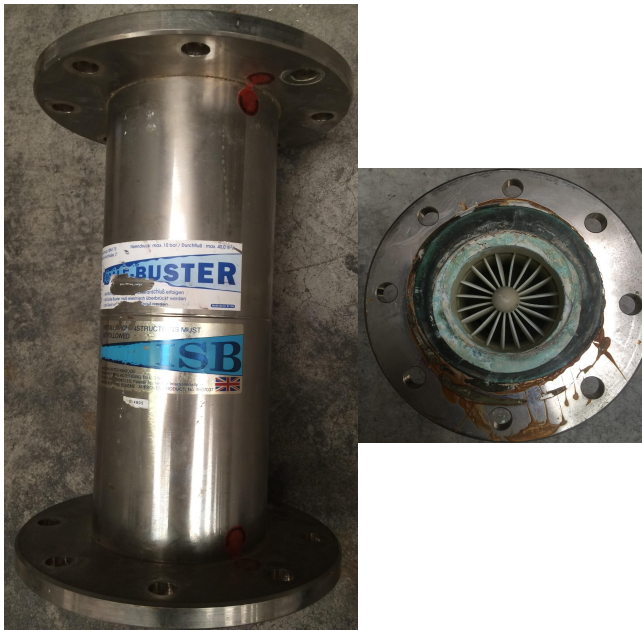
ScaleBuster DN75 - serial number 014805  
- supplied February 1999  
- 2nd generation fin design

External inspection showed the body of the units to be in good order. The nickel plating was in good condition and there was no corrosion or pitting of the brass.

The central spindle and all PTFE fins were in good order on the flanged units. All fins were present and were tight within their housing indicating that minimal reduction in the anode had taken place.

The PTFE sections within the ISB C50 threaded unit were clean and showed no sign of wear or fouling. All the zinc anodes were in place and although some signs of depletion were evident this was to be expected after having been in use since 1999.

Internal inspection of the body and anode revealed that internal bore of the brass body of the ISB was found to be in good condition and no corrosion of the brass body was evident.

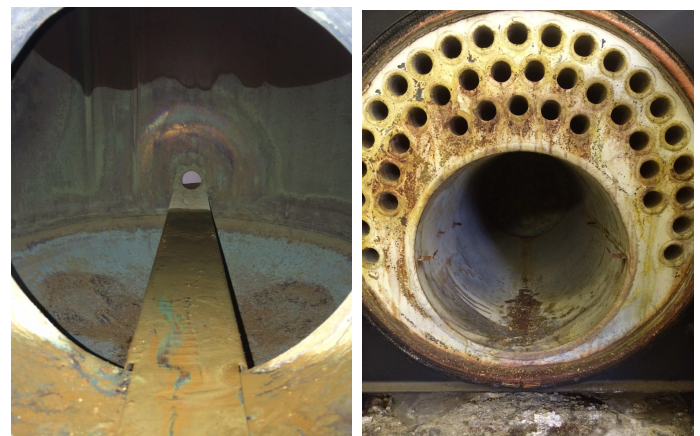
The contractor involved in the replacement of the calorifiers took pictures of the inside of the existing calorifiers before they were removed (see opposite). The images show no build up of scale on either the cylinder walls or the heat exchange walls.

Based on this evidence the ScaleBusters had performed their function of preventing the build up of hard scale within the calorifiers during their operational life.

Internal images of the calorifiers prior to removal
