## Tunnel Waterproofing, London Underground

(between Kings Cross and Farringdon Stations)

### SYSTEM COMPONENTS

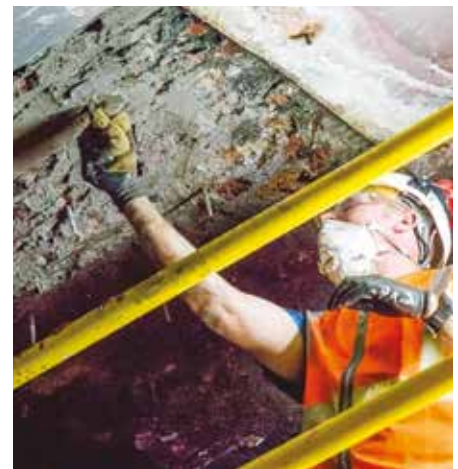
The construction of the tunnel is multiple layers of brickwork with an assumed tar or bitumen waterproofing layer externally. There was evidence of water seeping from the brickwork, stalactites, heavy salt and soot crust formations throughout the tunnel and a previous installation of injection packers which lined the crown.

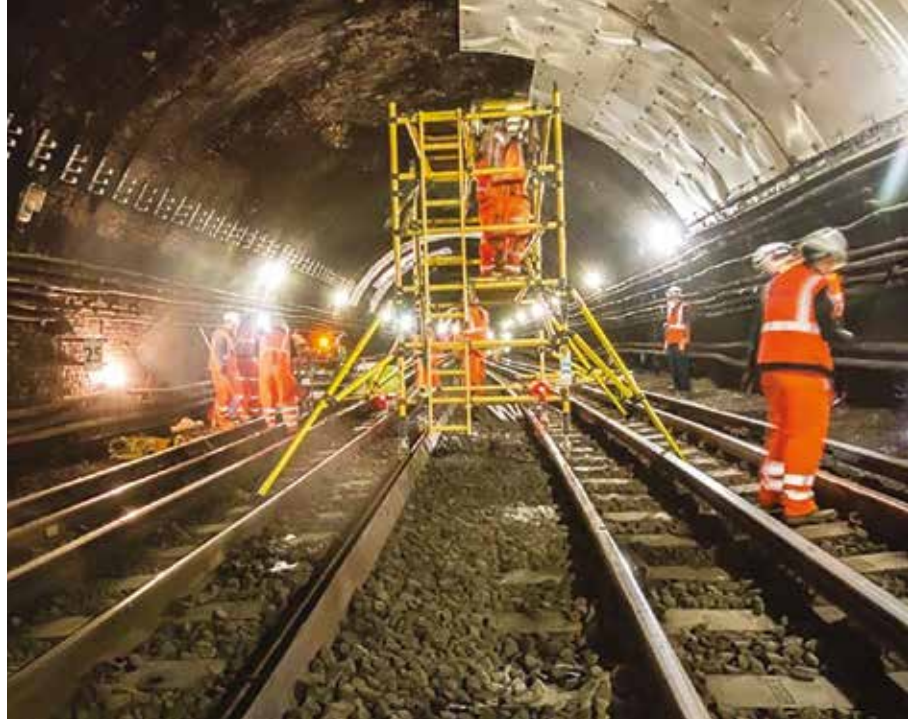
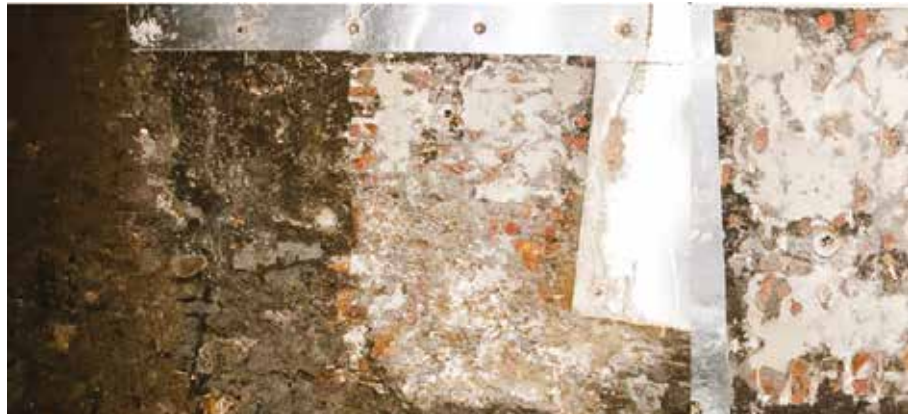
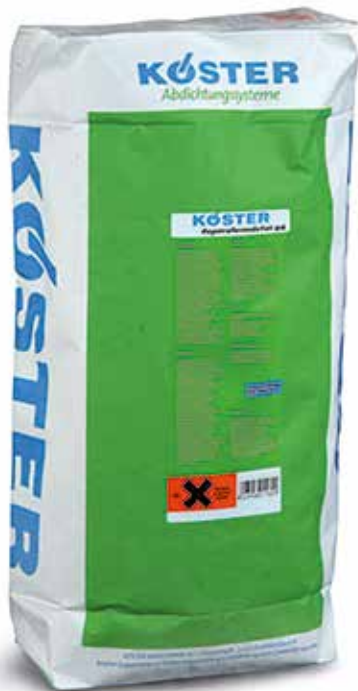
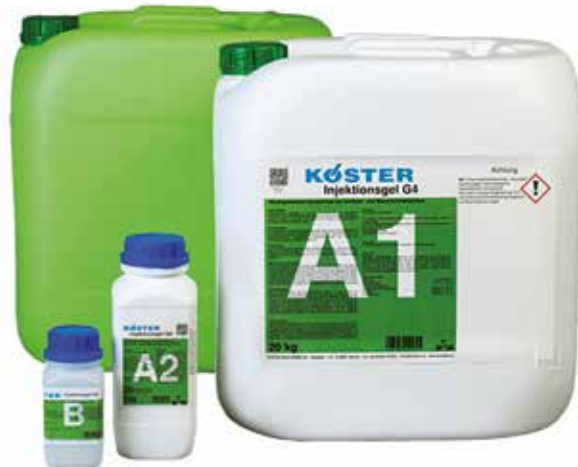
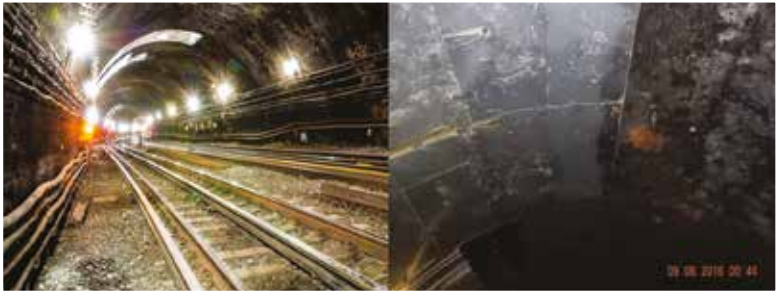
The areas of active leakage were evident (through old injection packer holes and badly pointed brickwork). These areas of active leakage were initially sealed using Koster Waterstop and KD2 Blitz. Both products immediately prevented the passage of pressurised water.

to measure and mark out the borehole positions for Koster Superpackers. Koster Superpackers are small injection lances which have been specially designed to give a superior grip (within the boreholes) whilst delivering a constant flow of grouting resin. Identifying the correct injection packer placement is an important process. Koster specified the Injection ports to be placed at 400mm centres in a grid pattern, with a single packer positioned in the centre.

The boreholes were drilled to a pre-determined depth which would facilitate the packers. Koster Superpackers were then inserted and the area was ready for

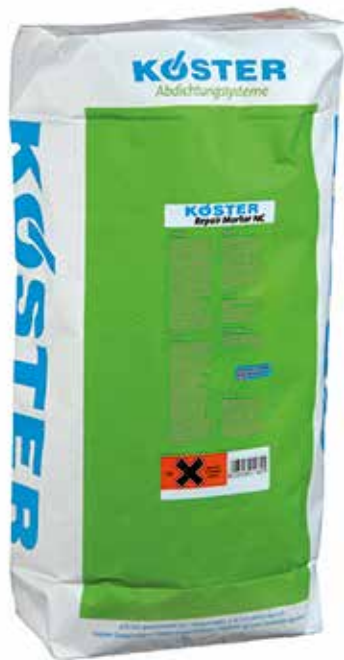
Following the injection phase, the Koster Superpackers were removed and the boreholes filled using Koster KB Fix 5 fast-set mortar.

The following night (during Koster's follow-up visit) the trial area was shown to be completely dry whilst the untreated brickwork surrounding the trial area was still wet with signs of seeping water.
