Harper Hill,
Buxton.
SK17 9JN

Tactile Paving Survey

**Report Number
HSL2005/07**

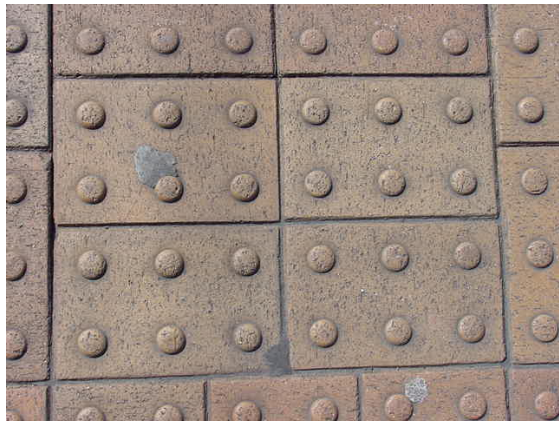
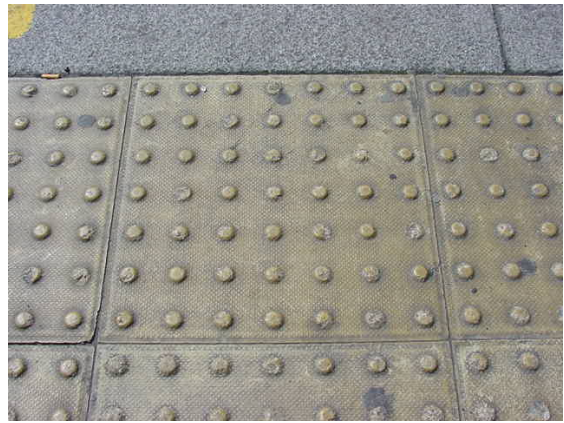
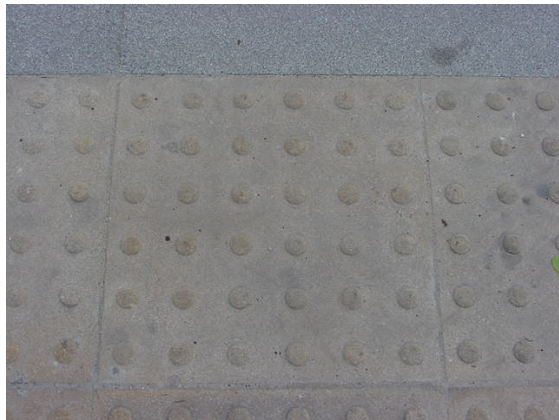
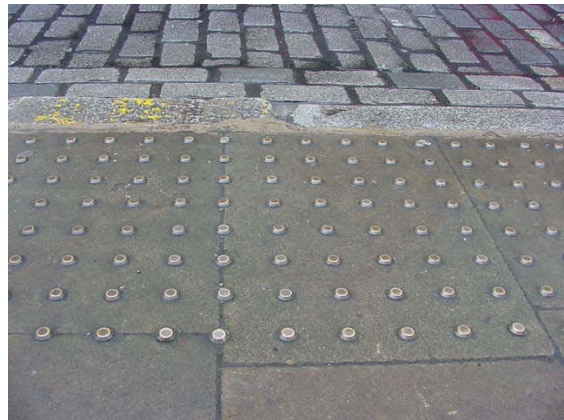
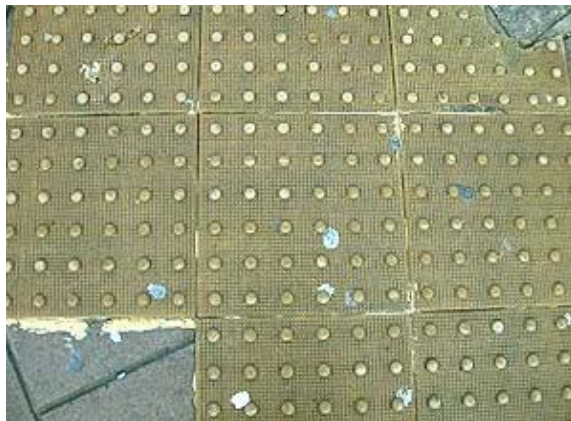
Figure 2.2 Photographs illustrating some of the wide range of tactile paving materials being used.

a) Block paviour blister tactile

b) Pre-cast concrete blister tactile

c) Natural stone blister tactile

d) In-set brass stud blister tactile

e) “Stick-on” tactiles [After McCormack]

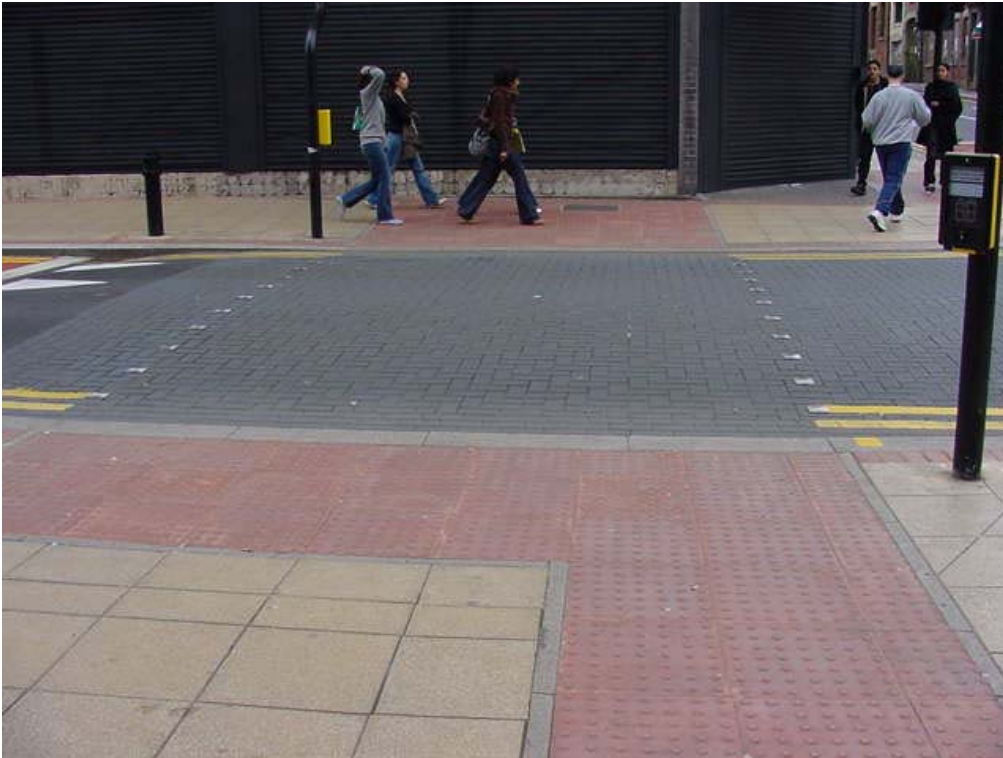
Figure 2.3 Photograph showing correct use of blister tactile paving at a controlled pedestrian crossing.

Examples of the correct use of the blister tactile surface at controlled and uncontrolled crossings are given in Figures 2.3 and 2.4.

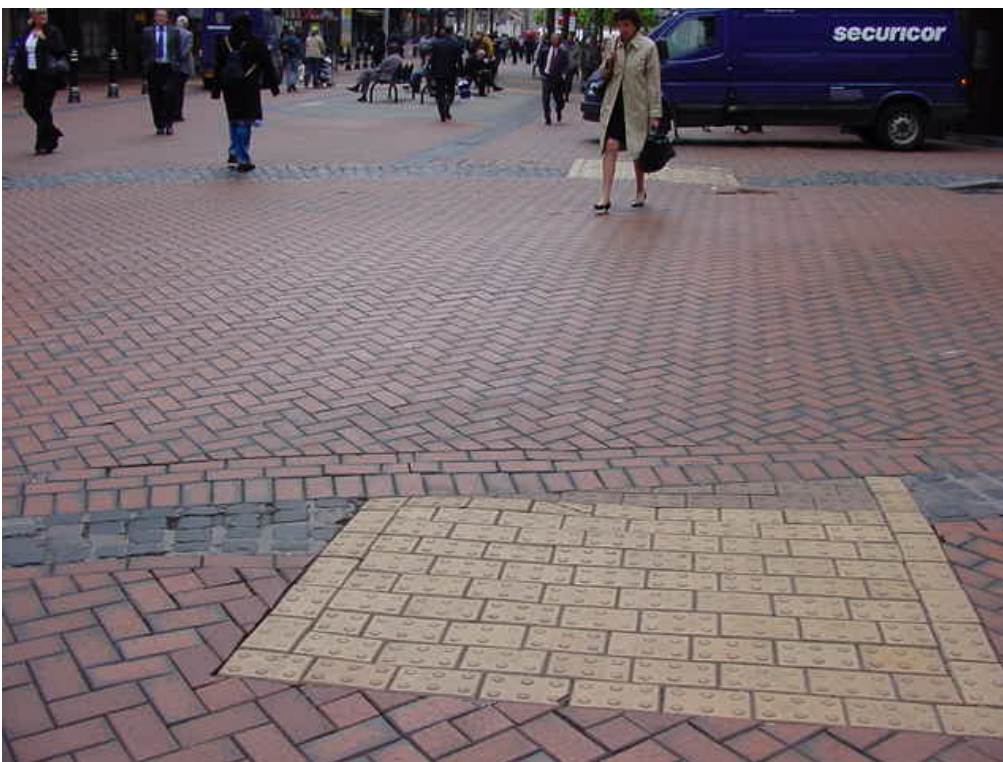
Figure 2.4 Photograph showing the correct use of blister tactiles at an uncontrolled pedestrian crossing.

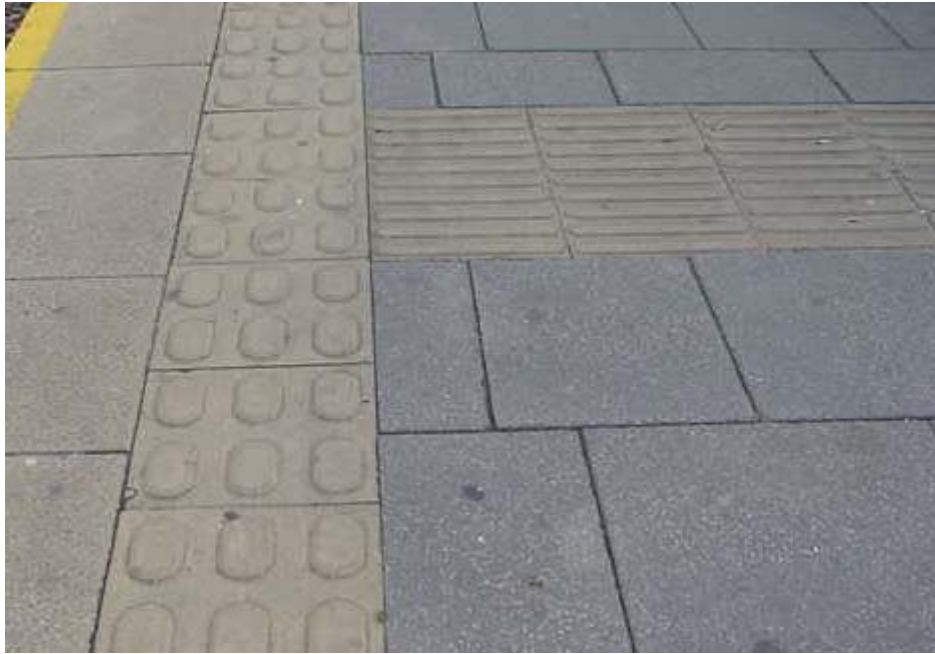
Figure 2.8 Example of correctly installed lozenge tactile paving at a tram stop.

An example of correctly installed lozenge tactiles is shown in Figure 2.8.

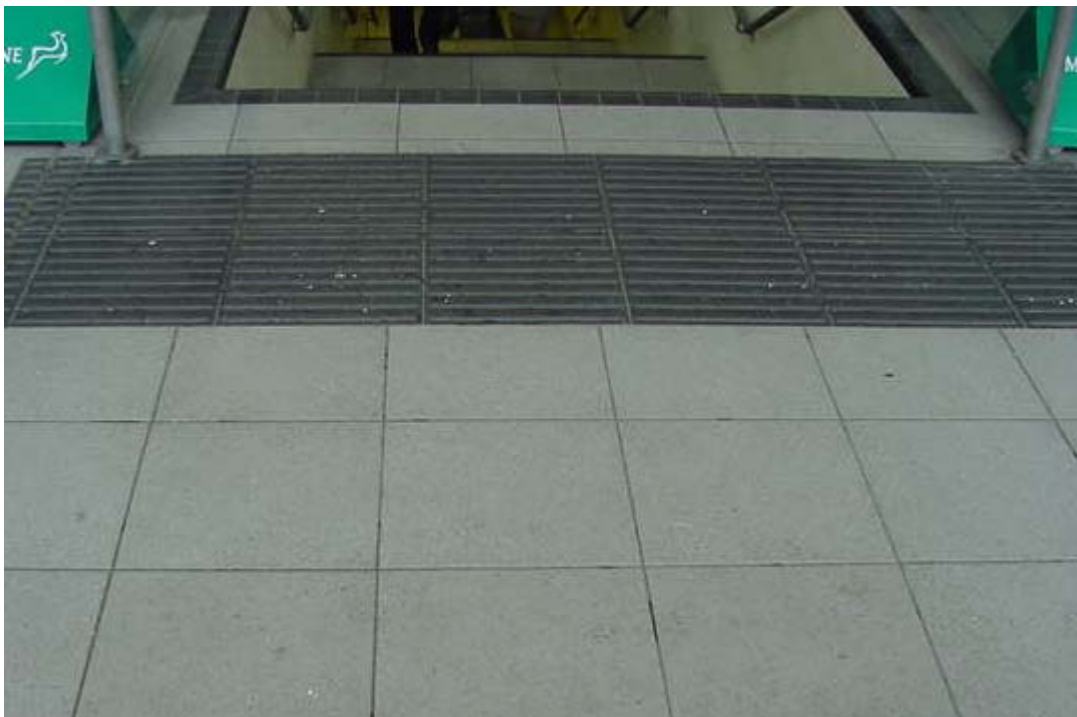
Figure 2.10 Picture of correctly installed corduroy tactile with good colour contrast with the surrounding floor.

An example of correctly installed hazard warning tactiles at the top of a flight of stairs is shown in Figure 2.10.

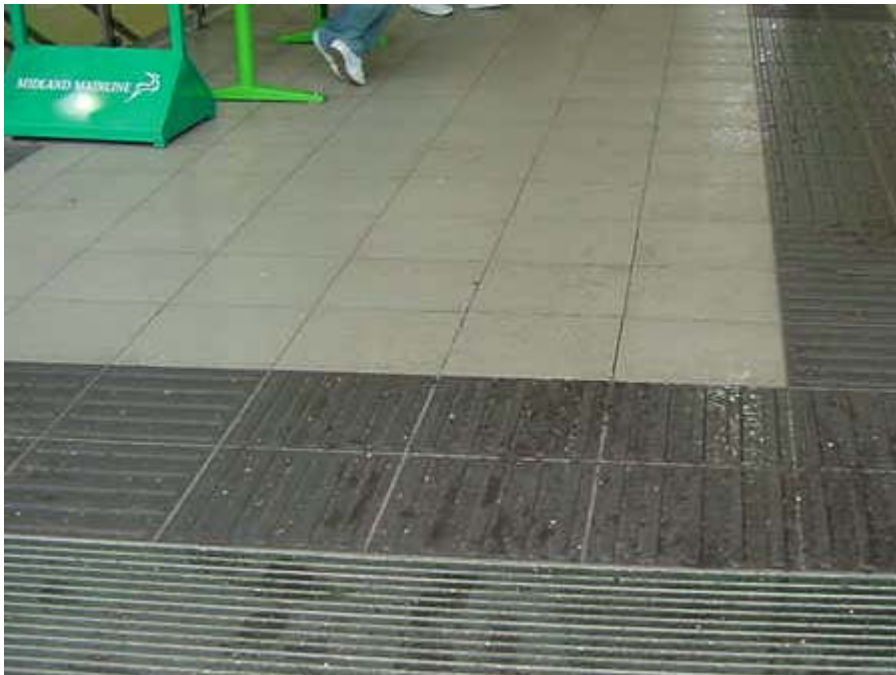
Figure 2.13 Example of correctly installed guidance path tactile, showing how easy it is to achieve good colour contrast with the surrounding flooring. In this example the tactile paving has been installed internally in a train station foyer.

An example of correctly installed guidance path tactiles is shown in Figure 2.13.

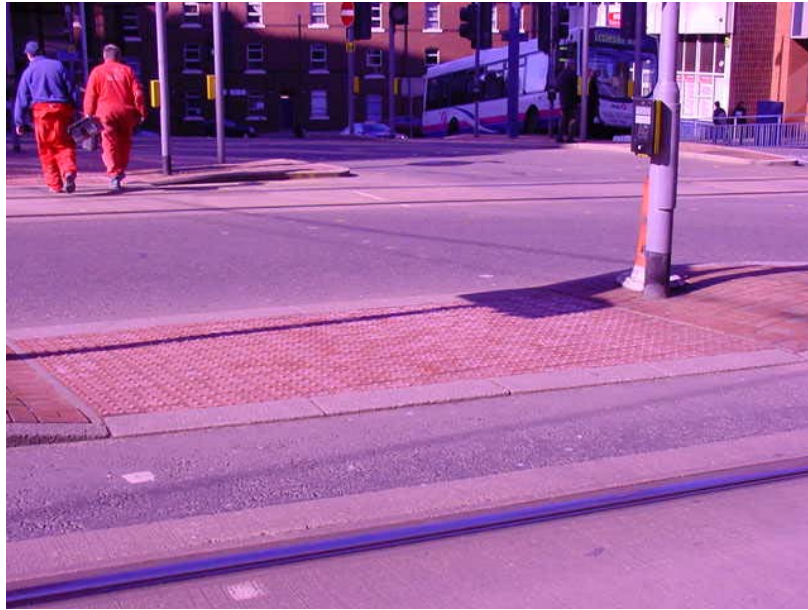
At all three controlled crossings identified above the contrast strip recommended in the guidance was missing.

Figure 4.1 Controlled crossing at junction of West Street and Leopold Street. Red blister tactiles have been laid to indicate dropped kerbs. Right pattern and colour, but no colour contrast with surrounding paving and there is no contrast strip between the tactile surface and the surrounding paving.

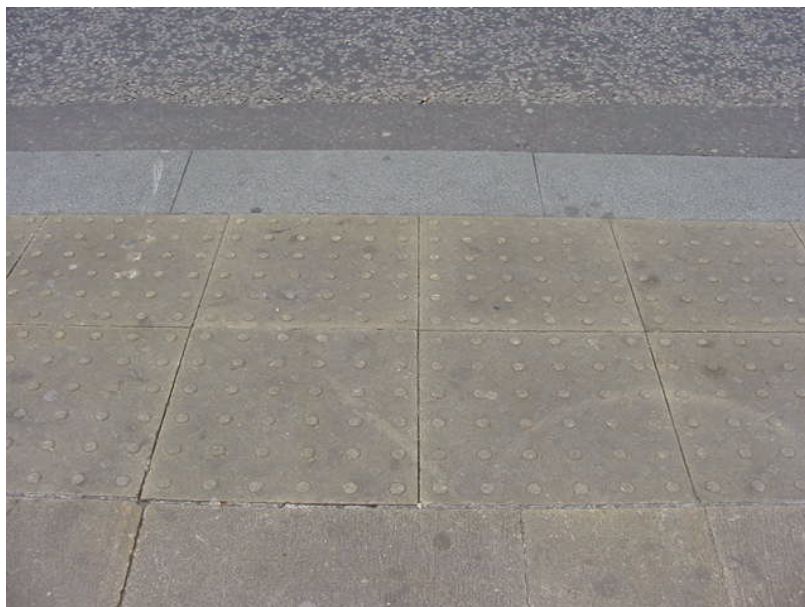
Seven uncontrolled pedestrian crossings with installed tactile paving were assessed for this survey. In all cases the correct pattern of blister tactile had been installed. However in five of the seven cases there was little or no contrast with the surrounding paving. The situation was worst around the redevelopment of the Peace Gardens and the Winter Gardens. Here the installed tactile paving is made from exactly the same stone as the surrounding paving, see Figure 4.2.

Figure 4.2 Peace Gardens uncontrolled pedestrian crossing. Tactiles used to indicate dropped curb. Tactiles made of the same stone as the surrounding paving so have no colour contrast.

Although it could be argued that the sand stone used is the correct buff colour for an uncontrolled pedestrian crossing there is no contrast at all with the surrounding pavement, nor is there a contrast strip installed. This clearly ignores the advice given in the guidance document, which repeatedly emphasises the use of colour contrast to aid partially sighted individuals and even raises the possibility that the tactile paving may pose a trip hazard to unwary members of the general public.

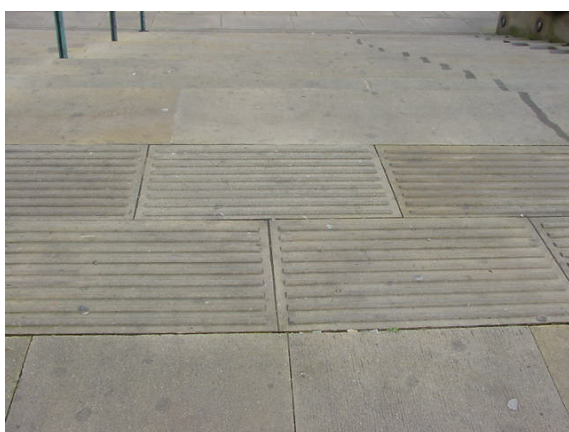
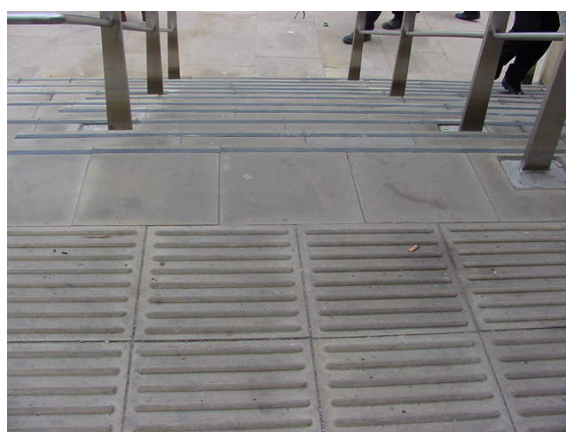
Figure 4.3 Corduroy hazard warning tactile paving installed at the top of stairs.

a) Peace Gardens

b) Winter Gardens

In both cases the tactile paving units used were made from the same stone as the surrounding paving and therefore had no colour contrast. This is a clear contradiction of the advice given in the guidance document which recommends, “the surface should be in a contrasting colour to the surrounding area to assist partially sighted people.”. Corduroy hazard tactile paving units are available in a wide variety of colours and materials, alternative tactiles which provided good colour contrast with the surrounding pavement could easily have been selected.

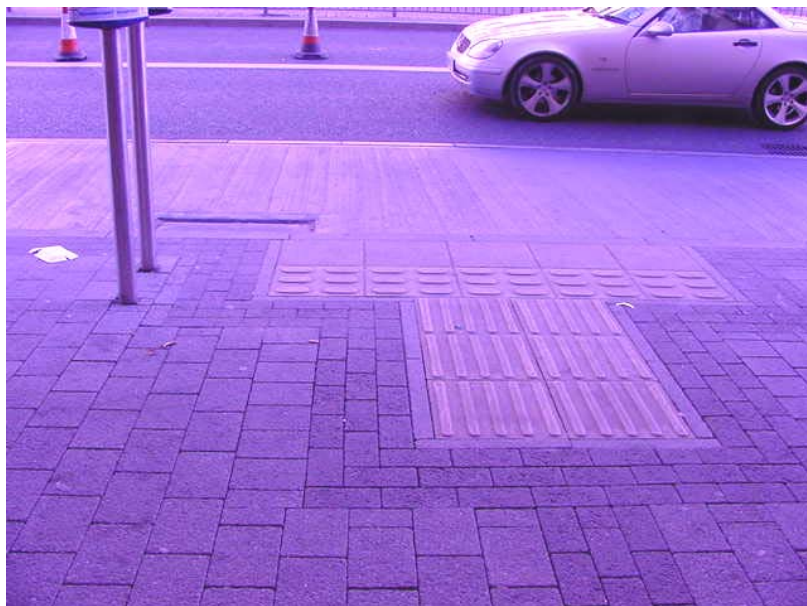
The most serious problem that can be encountered with tactile paving is the incorrect use of a pattern as this can give misleading and potentially dangerous information to blind and partially sighted people. Only one example of the improper use of a tactile paving pattern was found during the survey of Sheffield city centre, see Figure 4.5.

Figure 4.5 Bus stop on Arundel Gate. Buff lozenge tactiles have been incorrectly installed to indicate on street bus stop, directional guidance path tactiles have been installed leading to the bus stop.

The lozenge tactile has been installed at a raised bus stop. It is specifically stated in the guidance document that this warning surface is **not** recommended for use at bus stop locations.

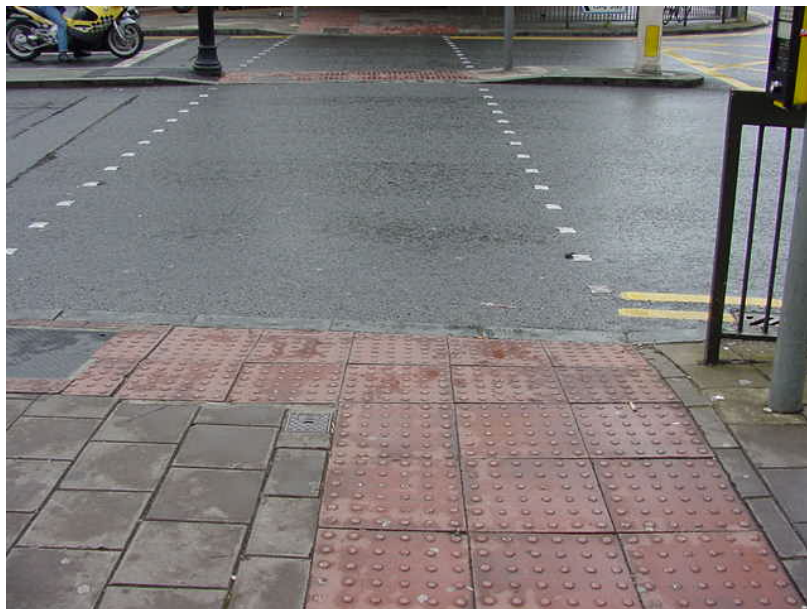
All three controlled crossing examined had correctly installed red blister tactile paving units which had good colour contrast with the surrounding paving, see Figure 4.6.

Figure 4.6 Junction of Grosvenor Street and Bridge Street. Tactiles installed to indicate controlled crossing. Correct use of tactile paving, good colour contrast with surrounding paving.

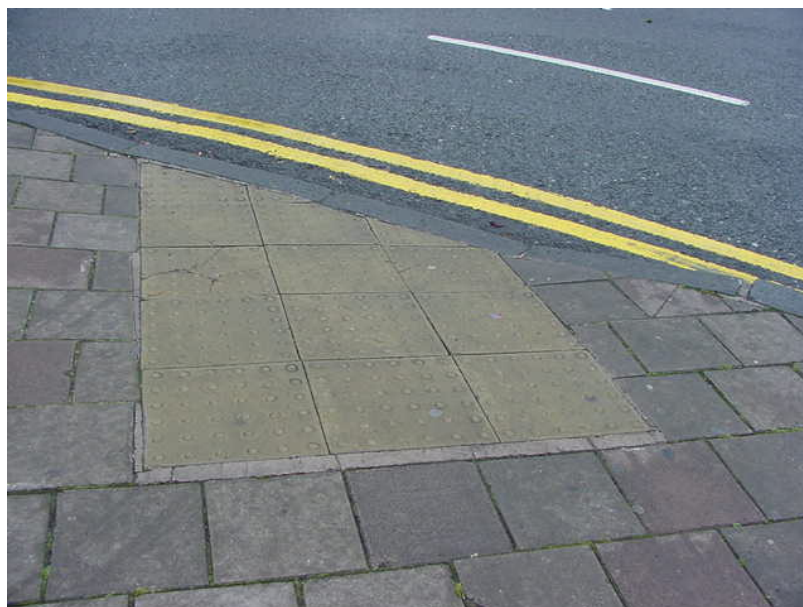
Figure 4.7 Junction of Newgate Street and Pepper Street. Example of buff concrete blister tactiles installed at an uncontrolled pedestrian crossing point.

Away from the more historic city centre its predominantly buff concrete blister tactile paving that is installed at uncontrolled pedestrian crossing points, see Figure 4.7. Five examples of crossings with the concrete blister tactile paving were identified during the survey. The condition of the paving was found to be generally good, the condition of the crossings may be summarised as follows:

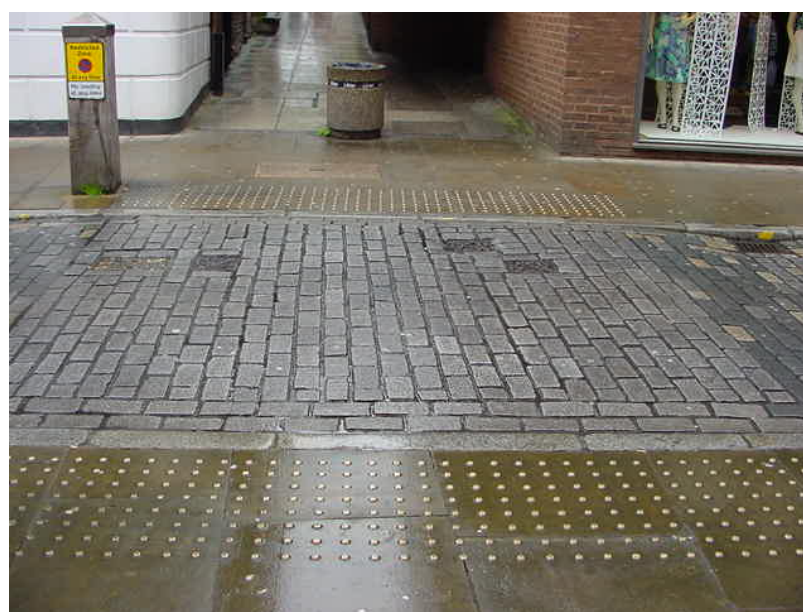
Figure 4.8 Uncontrolled crossing on Watergate Street. Brass studs have been installed into existing pavement. Right blister pattern, but no colour contrast with surrounding pavement.

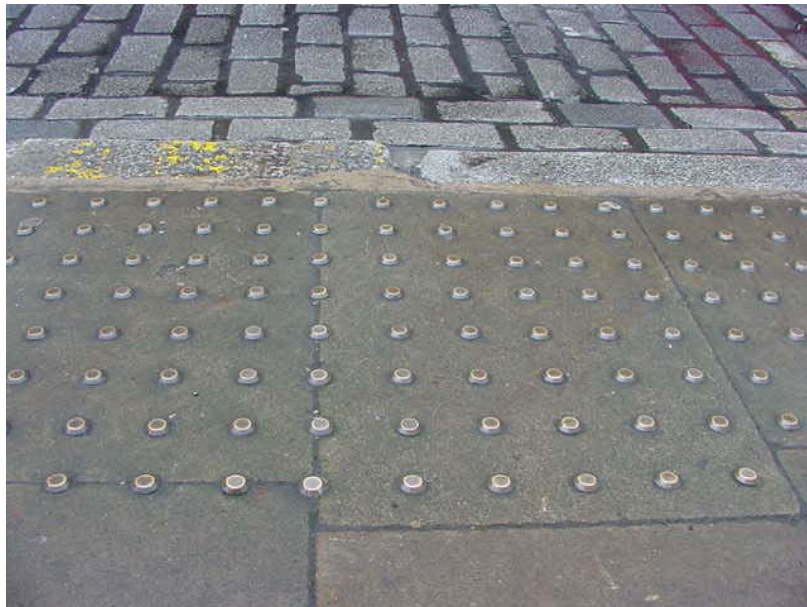
Figure 4.9 Detail of Upper Bridge Street uncontrolled crossing, showing brass studs set into existing stone paving.

The brass studs have been set into the correct blister pattern used to denote pedestrian crossing points. While it might be argued that stone paving used in Chester city centre is the correct buff colour specified for use at uncontrolled crossing points, the only colour contrast between the tactile area and the surrounding paving is provided by the brass studs themselves. It can be seen from the wider view of the Watergate crossing shown in Figure 4.8 that the colour contrast provided by the brass studs is limited compared to that achieved by other types of tactile paving.

In addition to reservations about the level of contrast provided by the metal studs there is also a concern that they could pose a potential slip risk in wet conditions. It is well known that the slip resistance of a flooring material is closely related to the level of surface roughness it possesses [HSE]. Visual inspection of the metal studs clearly showed that they had a tendency to wear smooth. Previous experience with smooth metal floors has shown that they pose a high slip risk when wet suggesting that the brass studs being used in may pose a slip risk during wet weather. A full forensic investigation of the inset brass stud tactile warning surface would be necessary to determine what level of slip risk they posed to pedestrians.

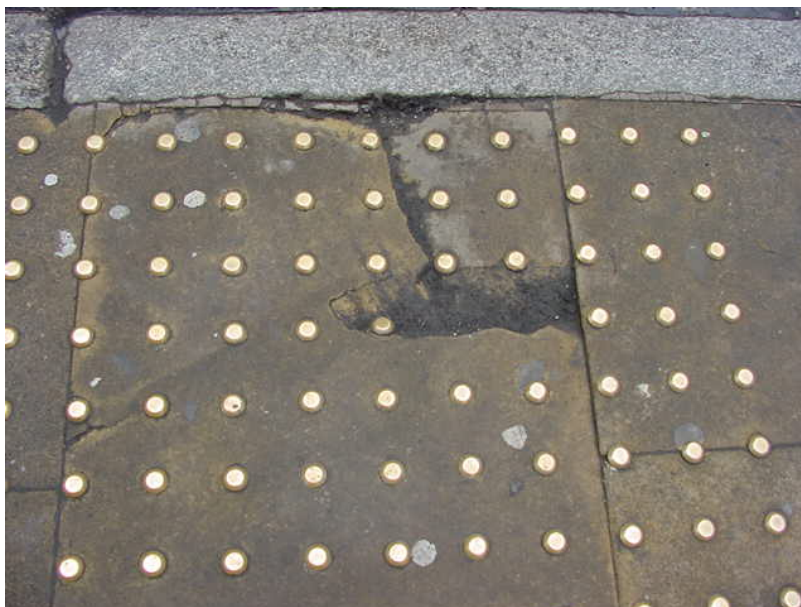
Eight examples of such crossings were identified during the survey. The condition of the paving was found to be generally good with only one crossing give cause for concern with regard to the condition of the paving, see Figure 4.10.

Figure 4.10 Detail of the pedestrian crossing at the junction of St. Wurberg Street and Eastgate Street. Installation of the studs appears to have weakened paving, causing a potential trip hazard.

The drilling carried out to install the brass studs appears to have damaged the structural integrity of the existing paving. As a result the slab has cracked and pieces have come away resulting in the production of a potential trip risk.

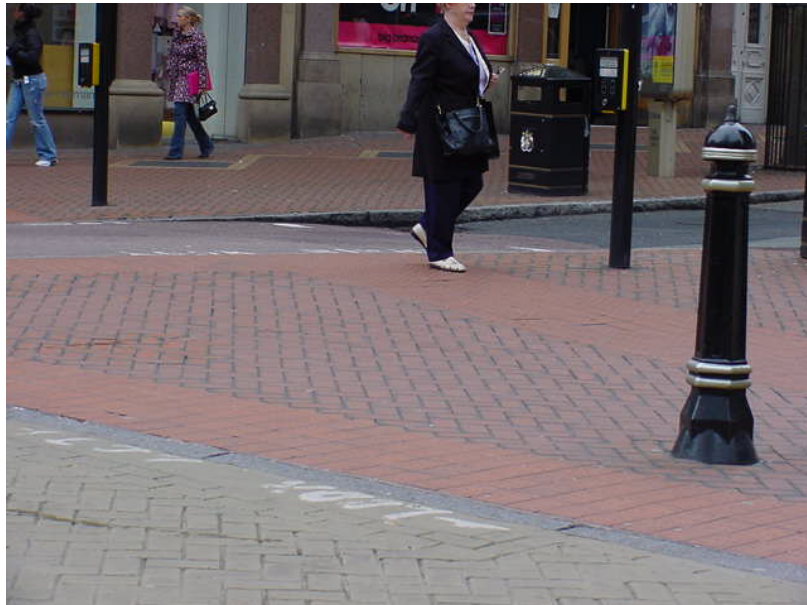
All three of the controlled crossings assessed in the survey had correctly installed red blister warning surface, however there were three cases where the warning tactiles had little or no colour contrast with the surrounding paving, see Figure 4.11.

Figure 4.11 Controlled crossing on Corporation Street. Clearly showing lack of contrast between the tactiles and surrounding paving, note the lack of the contrast strip recommended in the guidance document.

In the above example red brick blister pavements have been set into red block paving. The level of colour contrast with the surrounding pavement is low, the guidance on installation and use of tactile paving recommends the use of a contrast strip in such situations, but none has been installed at the above crossing.

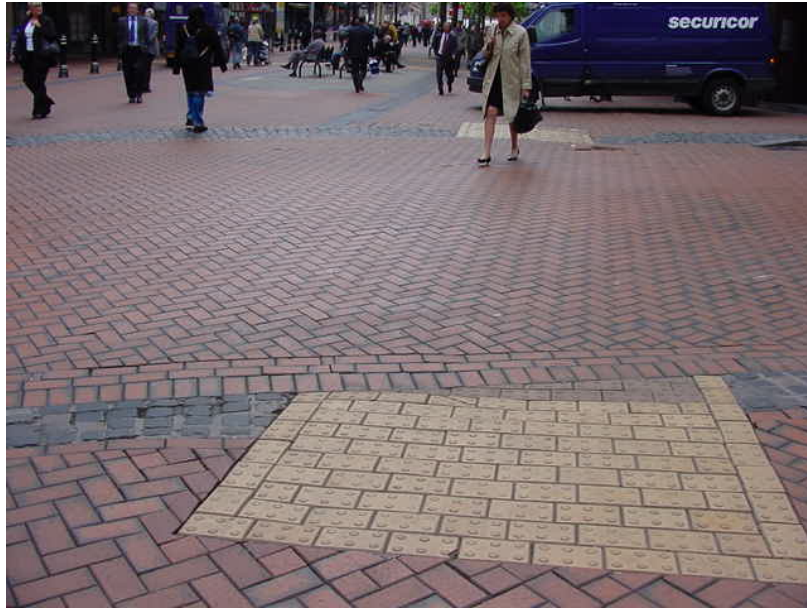
Five uncontrolled pedestrian crossing points were assessed for the survey, see Figure 4.12.

Figure 4.12 Uncontrolled crossing at the junction of New Street and Bennetts Hill, good colour contrast

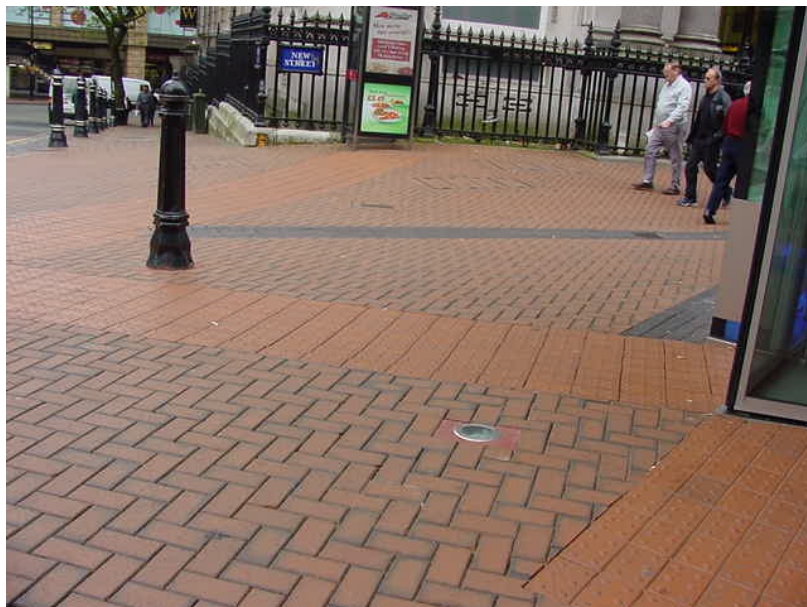
The most serious problem that can be encountered with tactile paving is the incorrect use of a pattern as this can give misleading and potentially dangerous information to blind and partially sighted people. Only one example of the improper use of a tactile paving pattern was found during the survey of Birmingham city centre, see Figure 4.13.

Figure 4.13 Junction of Corporation and Bull Street. Red block paving blister tactiles have been laid leading to a number of amenities.

In the above example blister tactile paving units have been laid in paths leading to a number of amenities, the telephone and building entrance. This is completely the wrong use for this

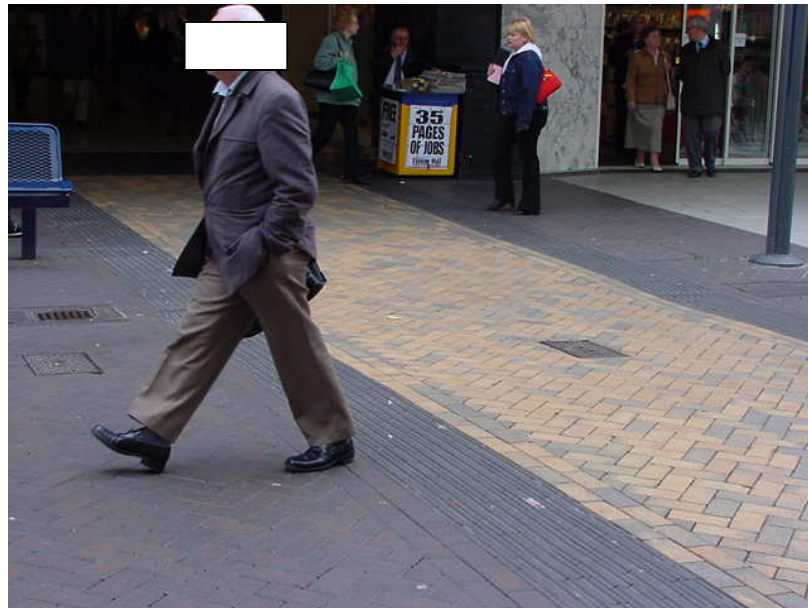
One example of the use of the corduroy hazard warning surface was identified in the course of this survey, see Figure 4.14. In this example the warning surface as been laid as a delineator strip to denote where two main pedestrian thoroughfares cross within a larger pedestrianised area.

Figure 4.14 High Street corduroy tactile used to demark walkway into shopping centre crossing the pedestrianised area.

In the guidance this warning surface is recommended for use in conjunction with stairs, ramps and level crossing, however it makes sense for it to be used in this situation. There is clearly a potential hazard for blind or partially sighted individuals who would be unaware they were about to cross another major pedestrian route. Unfortunately the colour contrast between the tactile paving and the paving in the main pedestrianised area is poor, use of a contrast strip or a different colour corduroy tactile paving would have been a better choice.
