Barrier type: MIB 20 / 30 / 40
Controller: MLC100

Failure Corrective Action

Error message: Sensor adjustment

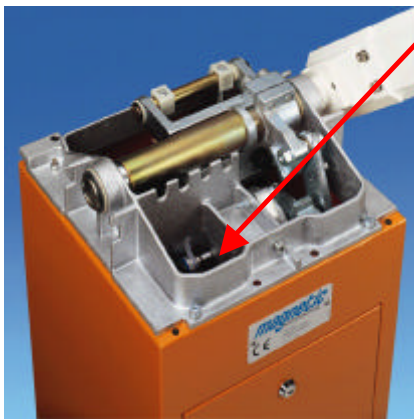
Boom angle sensor

The boom angle sensor transmits at any time the exact boom position to the controller. The MLC controller calculates the boom speed as well as the exact position from the input data. Based on these data the electronic brake is activated by the controller at the optimal point of time. The turn-off position of the safety device is met precisely to the degrees. In order to adjust the sensor properly the barrier type must be set as per to the operating manual when starting the MLC controller the first time.

In the event of the barrier stops in open position showing "adjust sensor" at the display one of the following errors may be responsible:

1. The sensor value of the open barrier is exceeding the tolerance that is between 555 and 565. (ref. operating manual annex 8.1)
2. The descending motor lever is has slipped through due to external force influence or vandalism. For this reason the sensor data cannot be in accordance with the must value.
3. Defect sensor
4. Defect controller
