Scope of Works

This Asbestos Management Survey of *Property Address* was commissioned on *insert date*. The purpose of the survey was to provide the client with sufficient information to enable them to comply with their duties under Regulation 4 of the Control of Asbestos Regulations 2012.

Survey ref: DJ150414A
Sample no: 01
Item: ceiling panels
Location: CP level filing area
Room no: -1/55

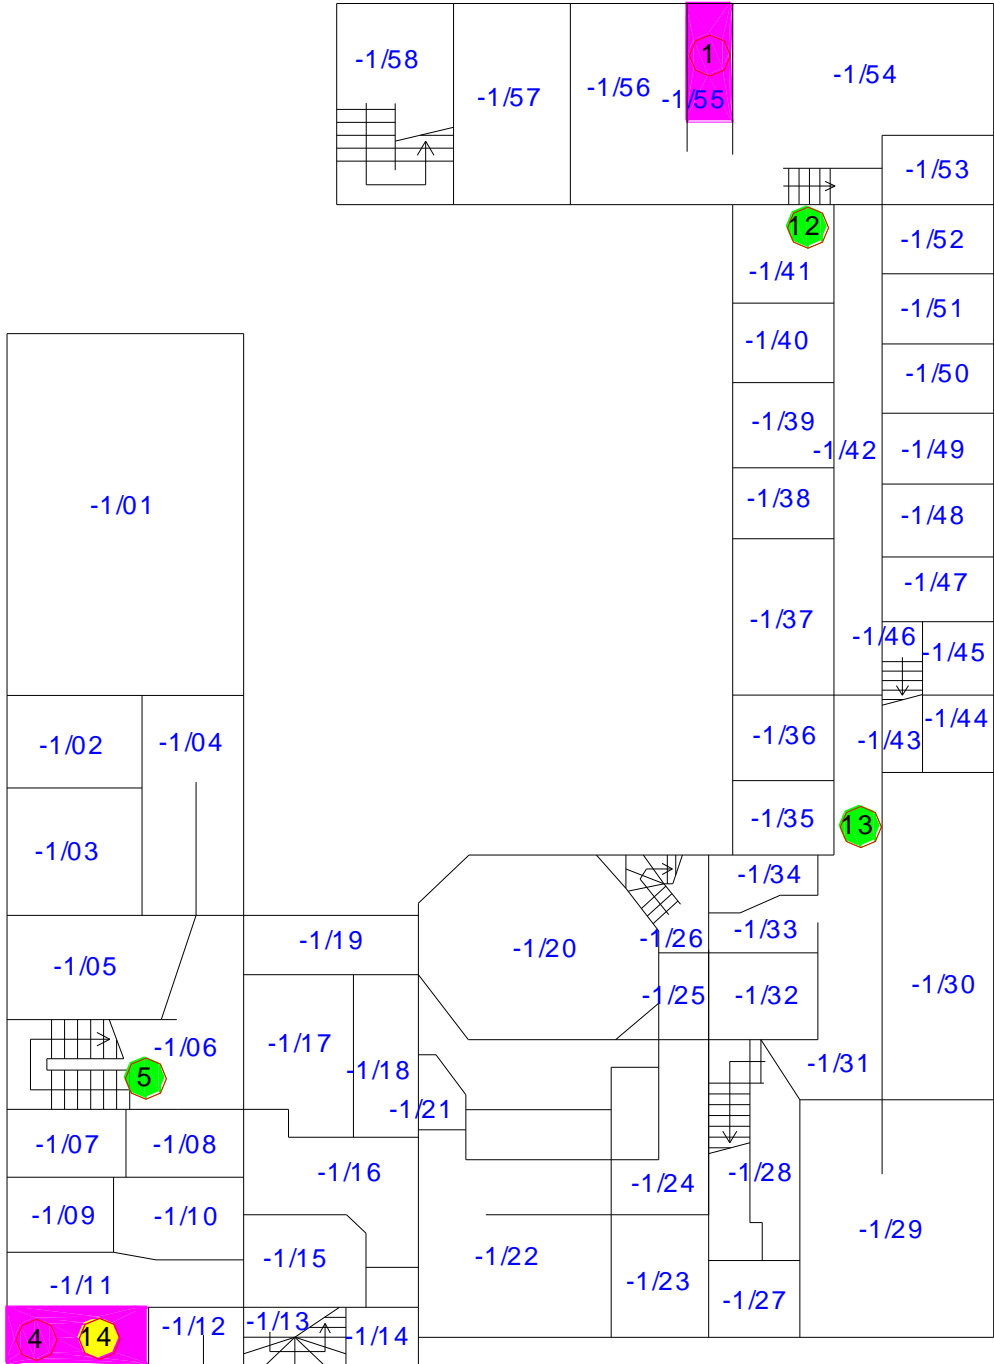
Car Park Level

Multiple **asbestos gaskets** are present within the Car Park level boiler room (see plan). Asbestos gaskets are a low risk material that may be managed in-situ. If necessary, removal work may be carried out by a suitably trained general contractor wearing appropriate RPE/PPE and following HSE guidance work methods. At the time of surveying, identified gaskets appeared in good condition.
