Social Housing

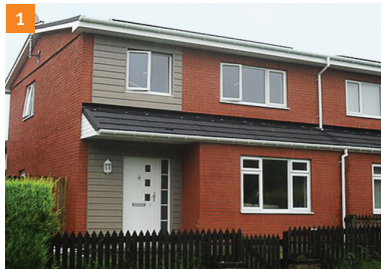
1 Tarran Newlands, South Tyneside

External refurbishment works to 98 Tarran Newland non-traditional houses in the South Tyneside area. Each property has received a WBS brick effect render finish with an option of accented cedar cladding or a 1.5mm 'K' silicone finish to lend the properties an attractive, modern appearance to go with the proven thermal benefits of insulated render.

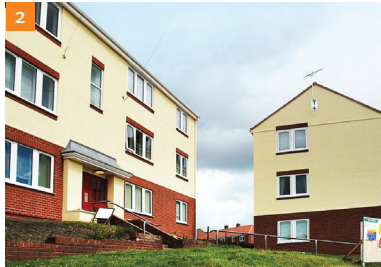
2 Unity Blocks, South West Denton

External refurbishment of two Unity housing blocks using an Alumasc Swisspan insulated render system which is used to over clad properties where the possibilities for mechanical fixing are restricted to structural elements. A brick slip system was installed at lower and applied above and below windows to help transform the appearance of the structures.

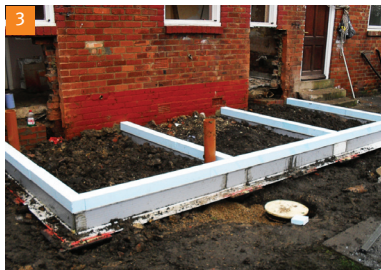
3 Modular Foundations, Walker

Installation of the Quickbase engineered modular foundation system to support single storey mono-pitched kitchen extensions as part of a wider scheme of property improvements. Each installation was completed in under two days and was immediately available for the construction of brickwork and blockwork by the main contractor.

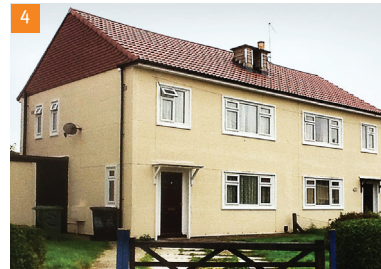
4 Orlit Properties, York

A series of external repairs to improve both the structural and aesthetic performance of 95 Orlit type non-traditional properties in the York area. Works centred on the repair, replacement and upgrading of concrete corner blocks and the reduction in height and restraint of chimney blocks where the reinforced concrete caps were found to be defective.

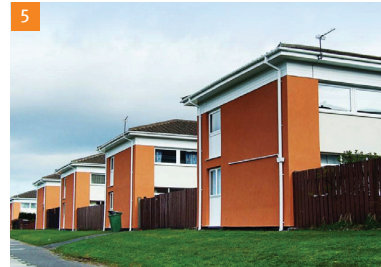
5 Wimpey No-Fines, Beacon Lough

External renovation of 115 Wimpey No-Fines dwellings and 55 Butterfly type non traditional properties for The Gateshead Housing Company. The properties benefitted from an Alumasc Silkolitt insulated render system which was installed to improve thermal performance. A mortarless brick system was used below windows and in communal alleyways.

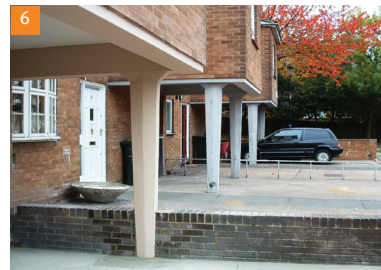
6 Concrete Repairs, Avison Street

Concrete repair project for non-traditional house types as part of a programme of works to repair and upgrade external structural elements, specifically the slender concrete pillars that support the bedroom above. Following steel reinforcement cleaning and specialist concrete repair, a carbon fibre structural repair system was applied to enhance resistance to impact damage.
