Case Study

Project: Training Centre
Product/system: Tor Coatings Elastaseal 15 Year System
Size/value: 1,100m²

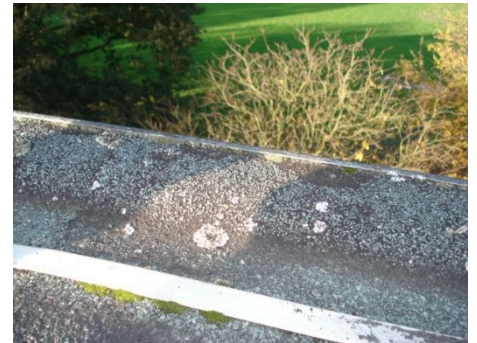
Lancashire Police had severe water ingress from the failure of the old bitumen felt roof covering. The building had to remain in constant use throughout the project, therefore hot works and noise disruption from stripping the old felt system was not acceptable to the client.

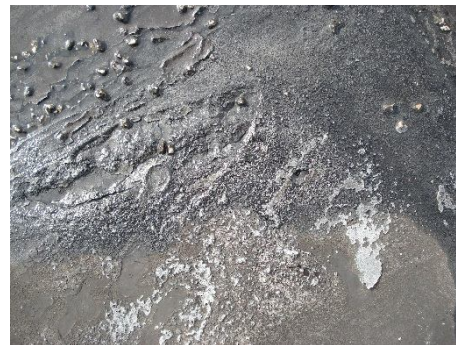
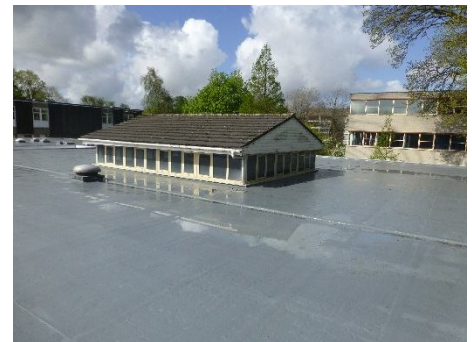
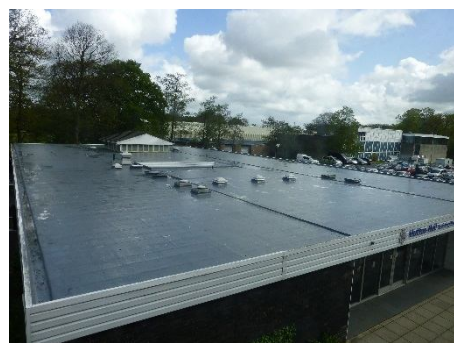
All works were completed on time and on budget and the pictures above clearly show the quality of finish and condition of site after handover.

All moss algae and stone chippings were removed from the deck. Any previous failed repairs were removed and made water tight. The roof was power washed to remove all surface contaminants before applying the Tor Coatings Elastaseal system, consisting of a fully reinforced base coat and a liquid applied top coat giving a 15 year single point guaranteed system.
