Case Study

Project: Hangar Refurbishment/Conversion
Product/System: Polymer Modified Render System with Protective Coating
Size: 600m²

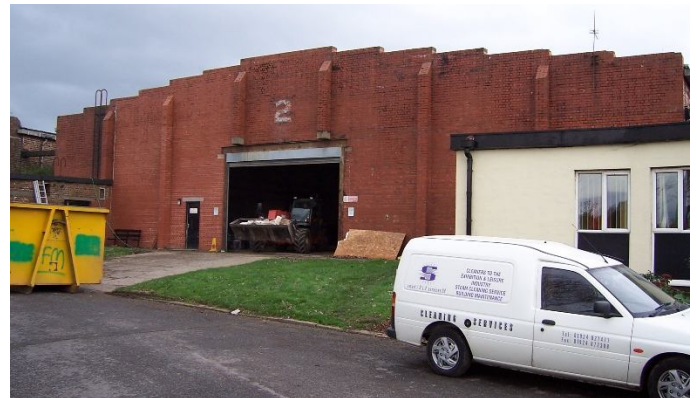
The external façade of the building was constructed from old engineering brickwork and the Zoo wanted to update and brighten the external appearance.

Gables offered a high performance polymer-modified render system with excellent adhesion to the hard engineering brickwork. This was over-coated with a compatible 15-year BBA certified weatherproof protective coating.

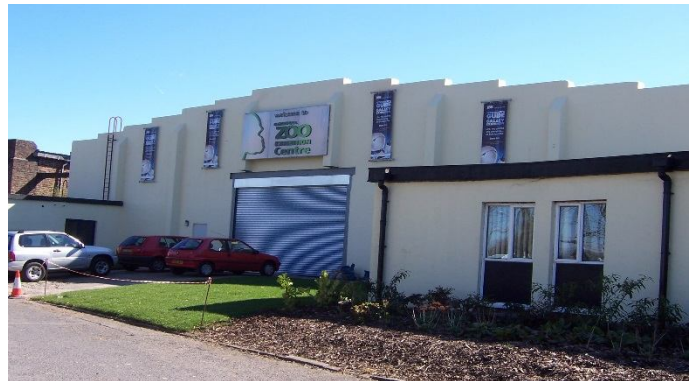
The coating has strong elastomeric properties resistant to cracking and flaking which will ensure that, despite the harsh elements of the Fylde coastline, the buildings will look pristine for at least the 15 year guaranteed lifespan.
