Case Study

Project: St Mark's House, Birkenhead
Product/System: Sika Liquid Plastics - Decothane HS & Flexcrete Technologies Ltd – Monolevel 844SP
Size: 1,600m²

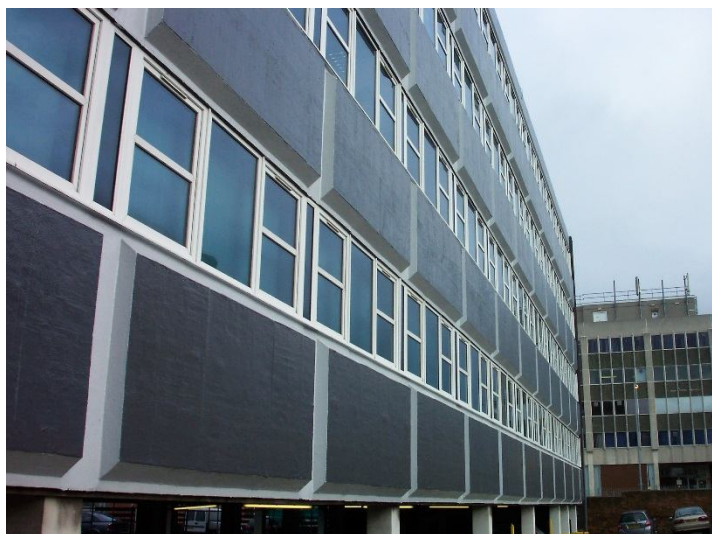
Completed Project

St Mark's House in Birkenhead, an office block was suffering from water ingress through the walls. The construction below the windows on each floor consisted of brick slips mounted on a prefabricated board. The brick slips were becoming loose and falling off in places causing the water ingress and presenting a potential danger to the office workers below.

Flexcrete's Monolevel 844SP, a cementitious repair mortar was used to flush point the brick slips and hold them in place. Decothane HS, a seamless waterproofing membrane, was then used to fully waterproof the building and ensure that no further spalling would occur.
